# Inspection Report

## Friendly Home Inspections

Sample Report

#### 1.1) Radon Test Results

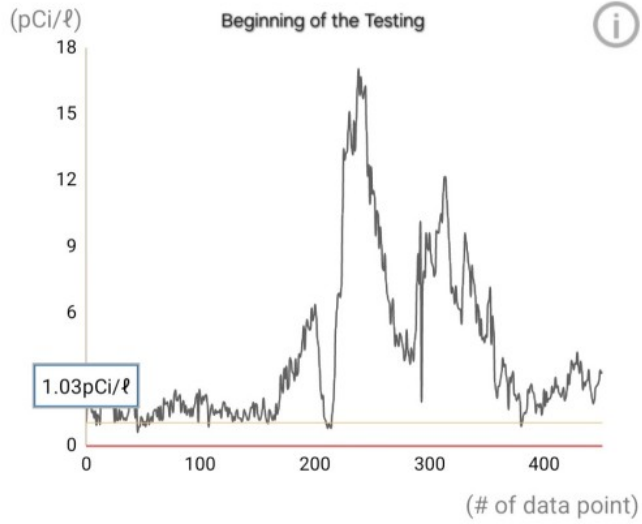
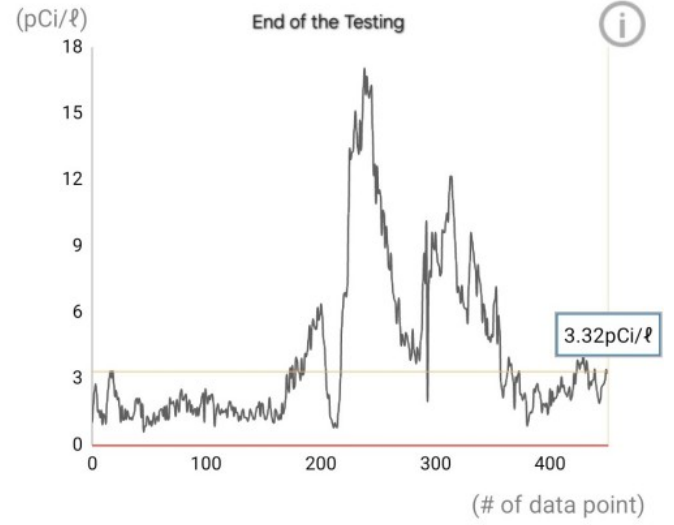
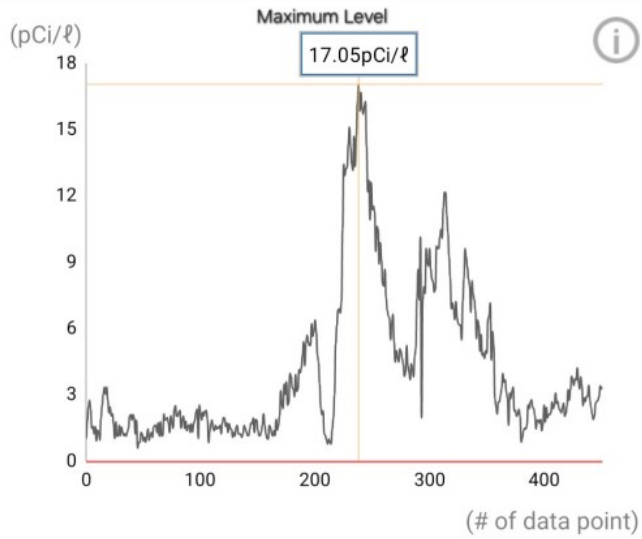
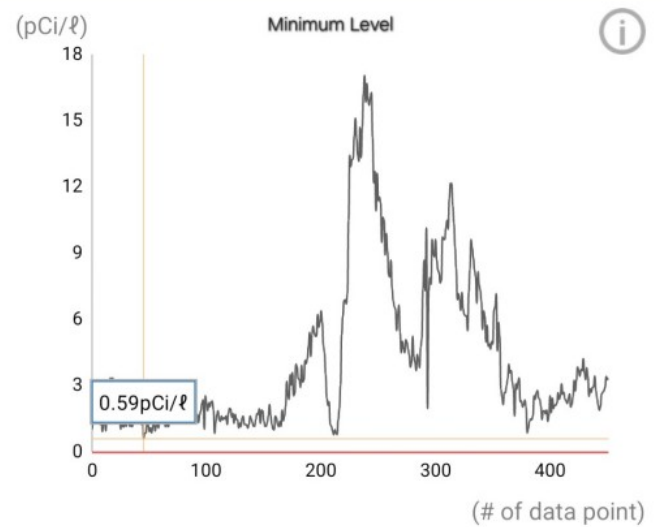
## Radon Data

Maximum Radon Level Recorded: 17.05 pCi/L

Minimum Radon Level Recorded: 0.59 pCi/L

Average Radon Level Recorded: 4.14 pCi/L

During the testing period, radon levels varied due to typical fluctuations caused by environmental conditions, changes in ventilation, and air pressure differences between the home and the surrounding soil. The measured radon levels ranged from a minimum of 0.59 pCi/L to a maximum of 17.05 pCi/L, with an overall average of 4.14 pCi/L.

The U.S. Environmental Protection Agency (EPA) recommends that homes with radon levels at or above 4.0 pCi/L should take action to reduce concentrations. In this case, the average level slightly exceeded the EPA action level, and the recorded maximum level was significantly elevated during portions of the testing period.

While the home is currently equipped with a radon mitigation system, these results suggest the system may not be functioning optimally, or environmental conditions during the test may have temporarily impacted radon levels. A properly operating mitigation system is typically expected to maintain indoor radon levels well below the EPA action threshold.

Given that the home has an active radon mitigation system installed but still returned an average reading above 4.0 pCi/L — along with a particularly high peak measurement — it is recommended that the mitigation system be evaluated by a licensed radon mitigation professional to ensure proper operation and effectiveness.

Once any necessary repairs or adjustments are completed, follow-up testing is advised to verify that the radon levels have been successfully reduced to below the EPA recommended action level.
