Inspection Report

Friendly Home Inspections

> Property Address 2510 Zane Dr SW Atlanta, GA 30331

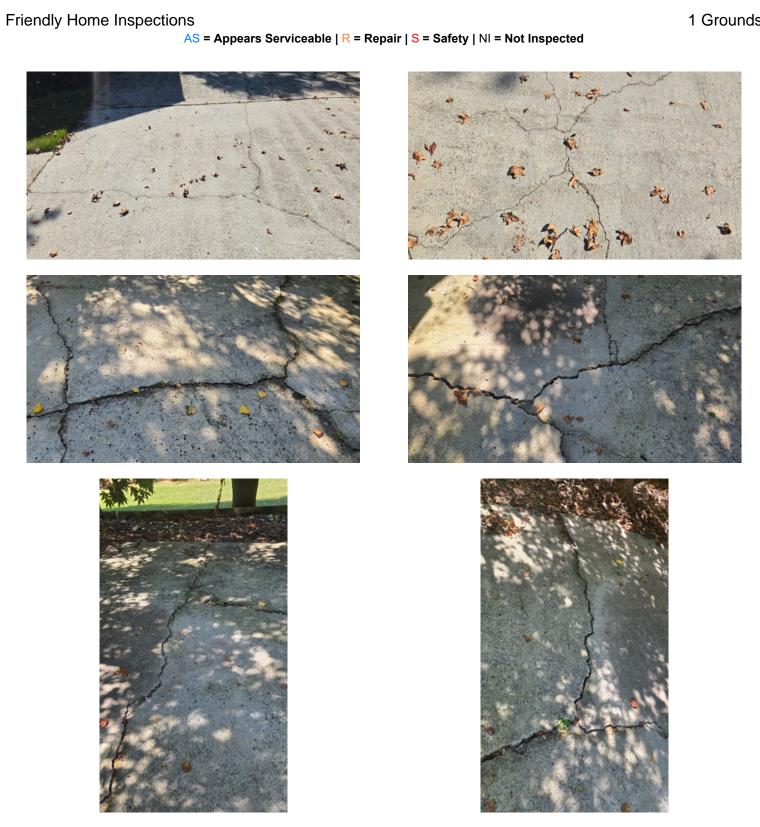
1.2) Driveway Conditions

Major cracks were found in the driveway. Tripping hazards were observed. These should be repaired for safety.
