Inspection Report

Friendly Home Inspections

Property Address 7376 Bluestone Dr Riverdale, GA 30296

Inspection Date March 4, 2022

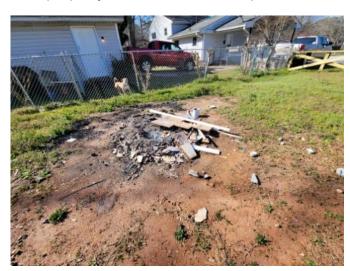
Excessive debris was observed. This can be a health and/or safety concern. Recommend clearing the property of all excess debris prior to close.

Trash pile in the backyard

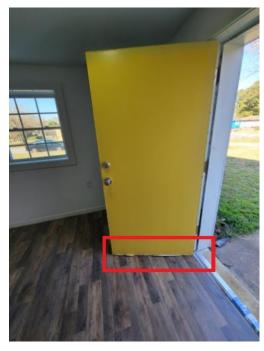
The front door top lock was difficult to operate. The back patio door sticks at the frame. Weather stripping was missing around the basement exterior door. Recommend repair and / or adjustment as needed.

Basement door rubs the floor

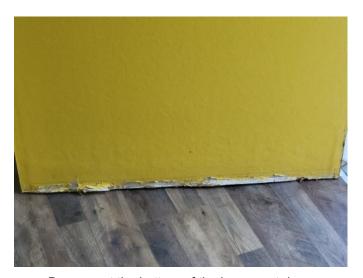
Damage at the bottom of the basement door.

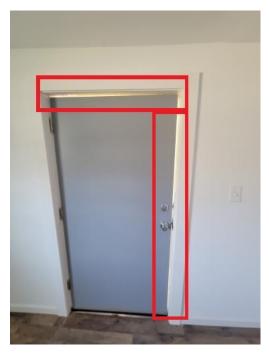
Sun light seen through the basement door

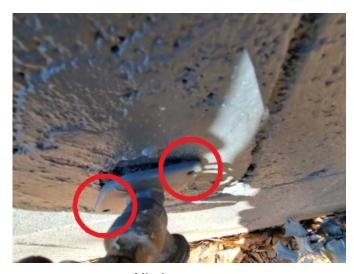
Both hose faucets and pipes were loose and not secure to the exterior wall. Recommend sealing where hose faucet pipes penetrates the wall.

Missing screws

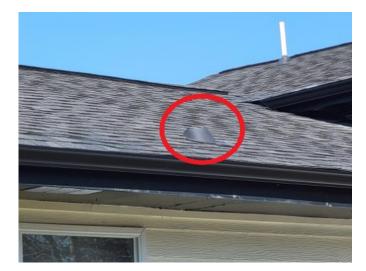
Minor sagging or depressions were observed to the roof sheathing and / or framing support. There looked to be an abandoned vent pipe hole over the kitchen area. This hole should be capped to

Abandoned vent pipe

avoid water damage to the roof sheathing. Two layers of roof shingles appear to be present. Today's standards allow a maximum of two layers of shingles. It is suggested that a "Licensed Roofing Contractor" be contacted for further evaluation and repair.

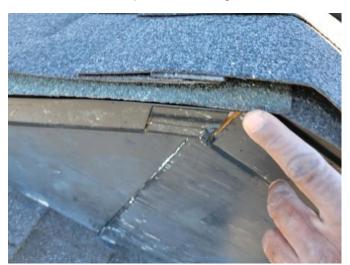
2 layers of shingles

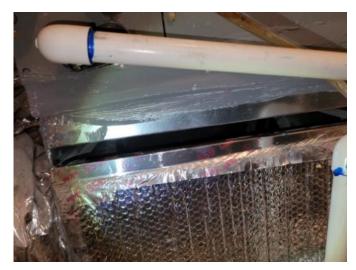
The air filter was missing at the time of the inspection. Recommend measurements be taken for the proper size filter. The correct size should be installed as soon as possible. The heating system was operational at time of inspection. This is not an indication of future operation or condition.

No filter

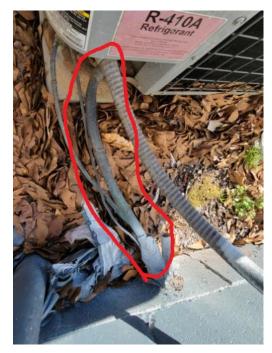
The insulation on the refrigerant lines was missing and deteriorated. Recommend installing this rather inexpensive pipe insulation to improve efficiency. Pipe insulation is available at most hardware stores. The cooling system was operated the last 20 minutes of the inspection once the temperature was over 65 degrees. The system was operational at time of inspection. This is not an indication of future operation or condition.

Missing insulation

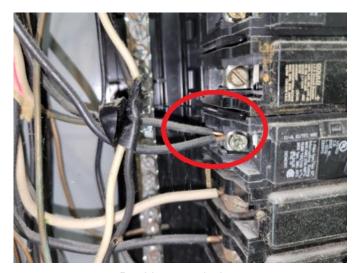
Two or more wires were connected to one breaker in the panel. This condition can add to the load of the affected electrical circuit causing a possible overload, tripping, or arcing at the breaker. Current standards require circuits to be independently protected. Recommend an electrician properly separate circuits.

Double tapped wires

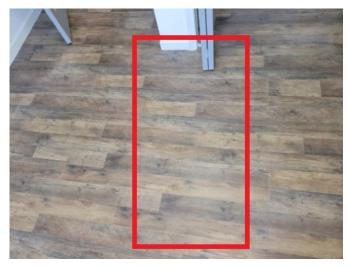
The floors squeaked in the first bedroom on the left. Recommend securing floorboards and / or repair as needed. The general condition of the visible and accessible portions of the floors appeared to be in serviceable condition at the time of the inspection.

Floor squeaks in this area

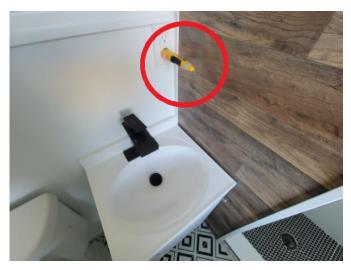
Three pronged outlets did not test for proper ground in the basement bathroom. Recommend further evaluation and repairs by a licensed electrician prior to close. The GFCI (ground fault circuit interrupter) receptacle did not respond to the inspectors (external) trip test device. Replacement and / or repair is needed. Recommend further evaluation and / or repair by a licensed electrician prior to close.

Open ground

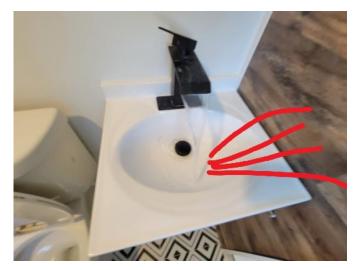
The basement sink faucet water splashes on the wall when the faucet is on. Repair may be warranted.

Water splashes on the wall

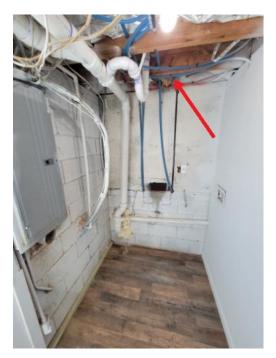
Laundry Room ceiling

Stains were observed at . When checked with a moisture meter the area indicated a wet / active leak condition. Recommend further evaluation and repair as needed by a qualified / licensed contractor. Please refer to limitations of inspection regarding mold / moisture related conditions.

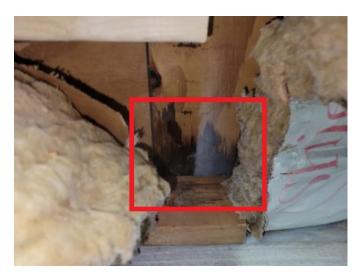
Moisture stain

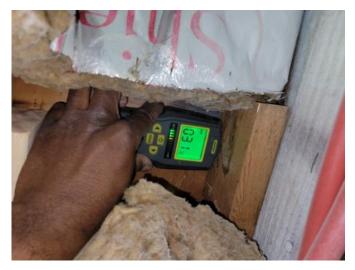
31% moisture

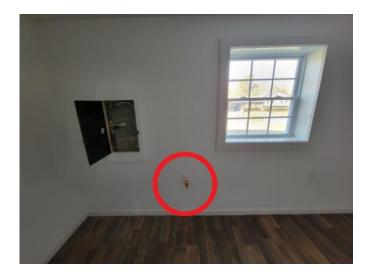
Three pronged outlets did not test for proper ground in the front bedroom. A missing outlet cover was observed in the utility closet. A junction box cover was missing in the laundry room. Recommend installation of covers for increased safety. Recommend further evaluation and repairs by a licensed electrician prior to close.

Open ground

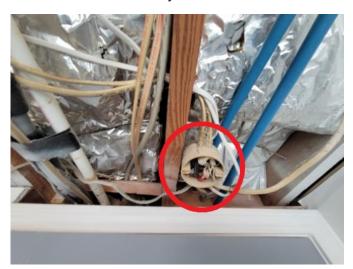
Cover missing

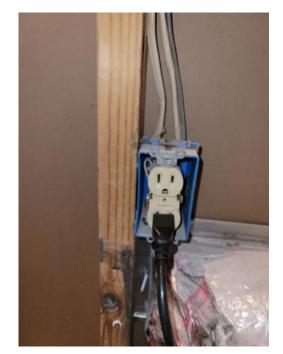
Cover missing

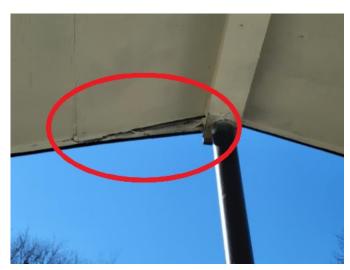
Damaged ceiling was observed at underside of the ridge of the roof. Recommend further evaluation and repair as needed by a qualified / licensed contractor.

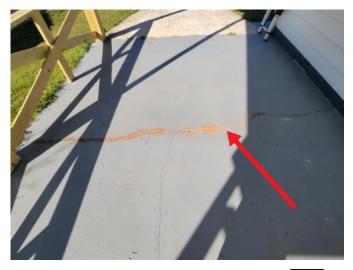
A crack was observed to the concrete flooring. Recommend further evaluation by a masonry contractor.

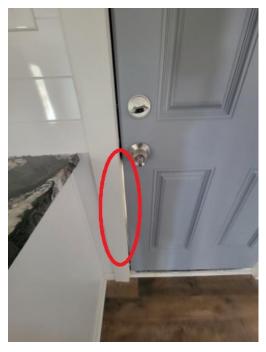
Weather stripping was missing from around the door. Recommend installing the strip to improve installation.

Sunlight in the door jam
