# Inspection Report

## Friendly Home Inspections

Sample Report

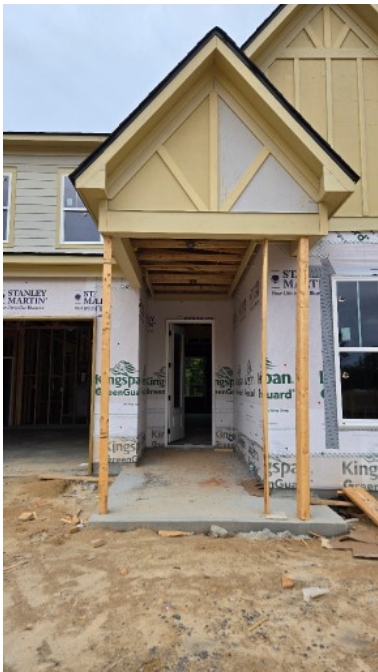
### 1.1) Front Entrance Conditions

Front Entrance Type     The front entrance is a covered porch.

The visible and accessible areas of the porch structure at the pre-drywall stage of the inspection appeared to be in serviceable condition at the time of the inspection.

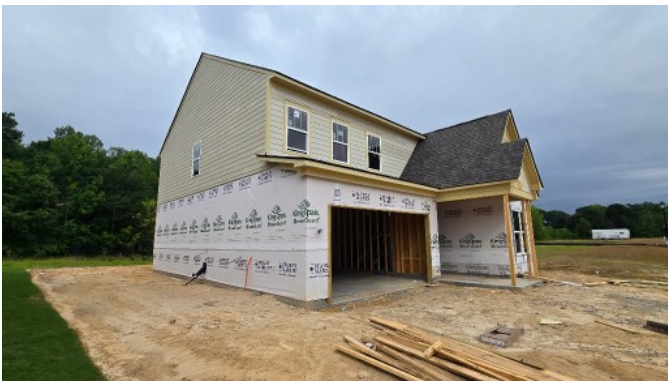
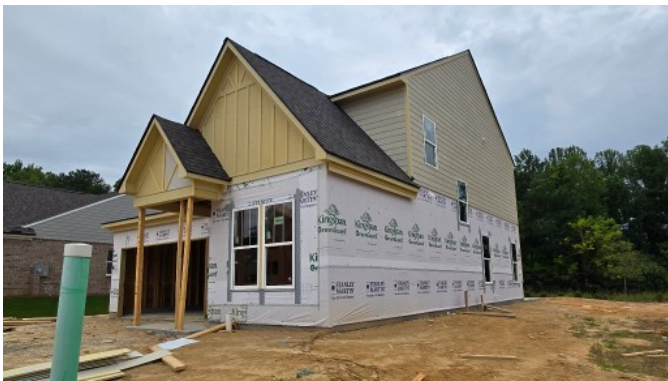
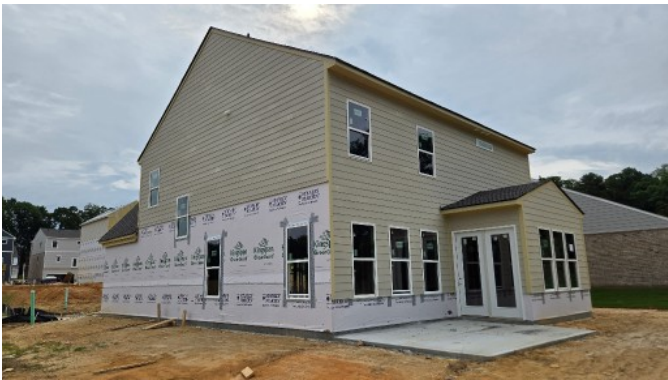
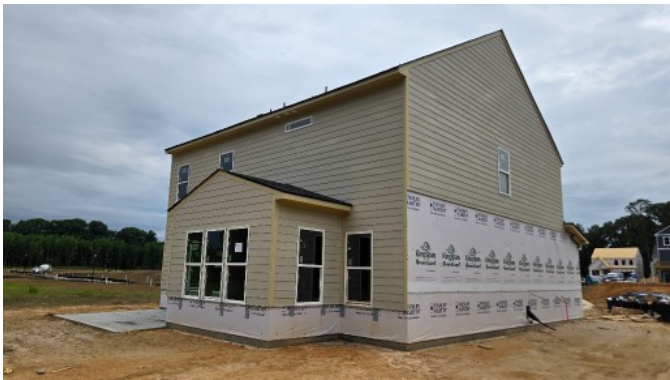
**1.2) Exterior Wall Conditions**

**Exterior Wall Covering**    The visible and accessible areas of the exterior siding material are wood.

The visible and accessible portions of the exterior wall coverings appeared to be in serviceable condition at the time of the inspection.

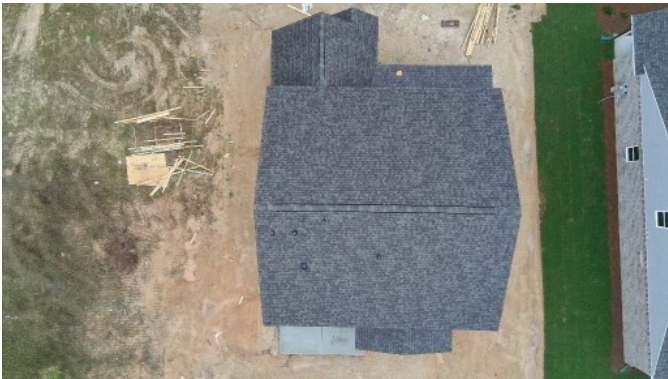
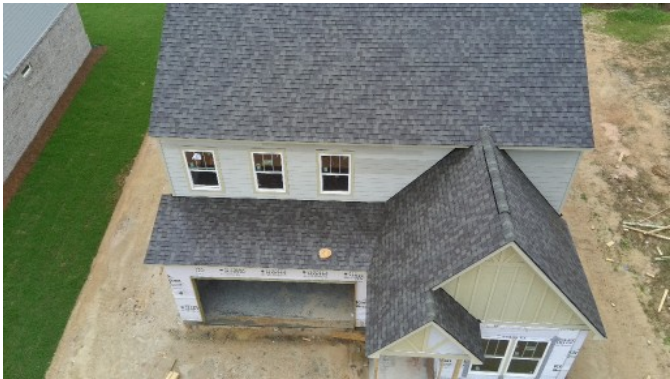
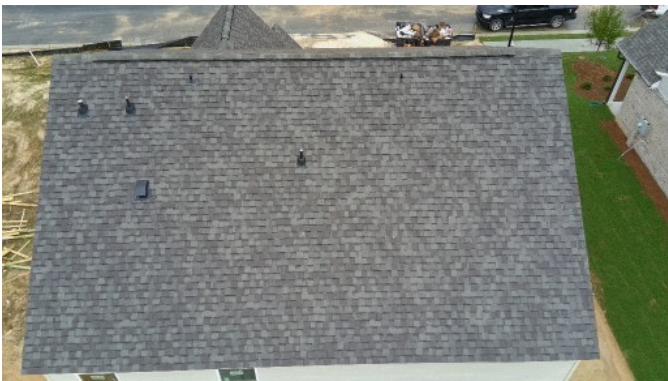
2.1) Flashing Conditions                      AS

**Method of Inspection**    The roof was not mounted due to height. The roof was inspected by viewing with high power binoculars and drone.

The exposed flashings appeared to be in serviceable condition at the time of inspection.

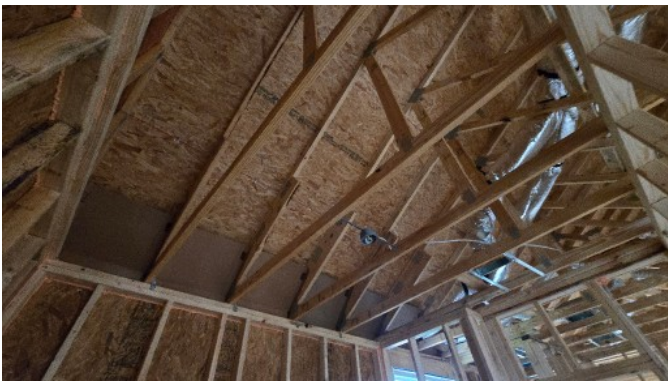
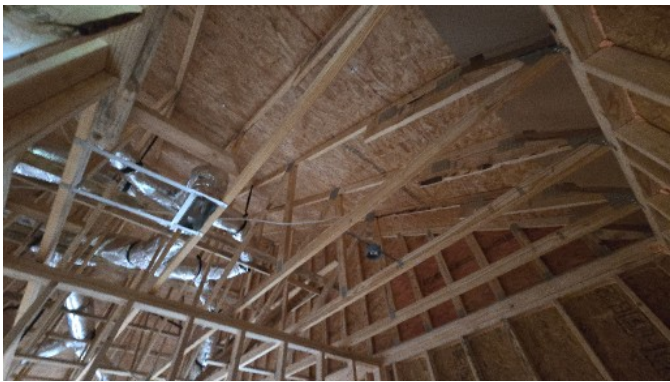
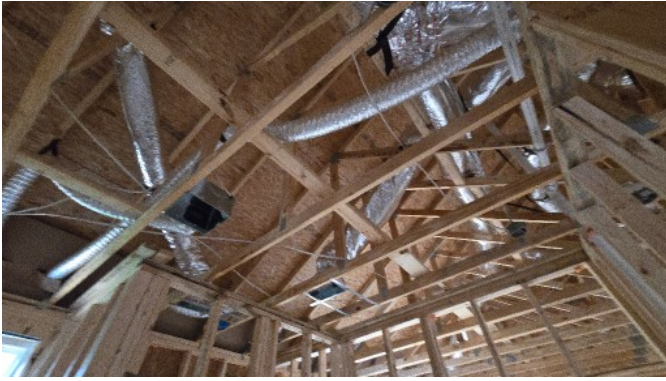
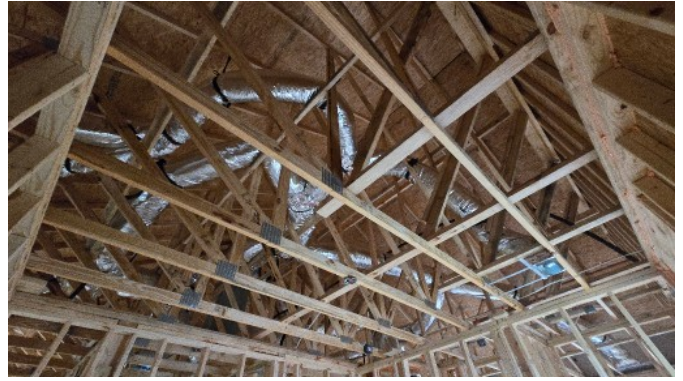
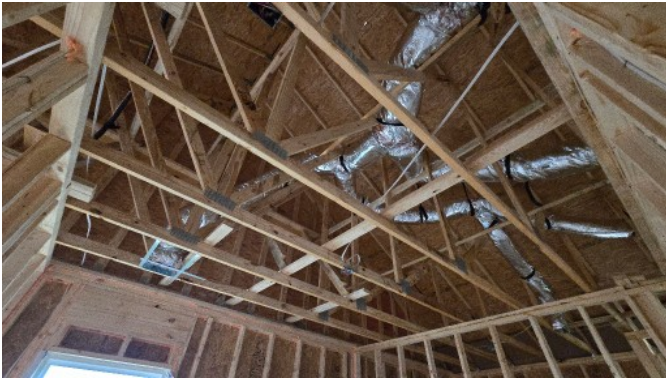
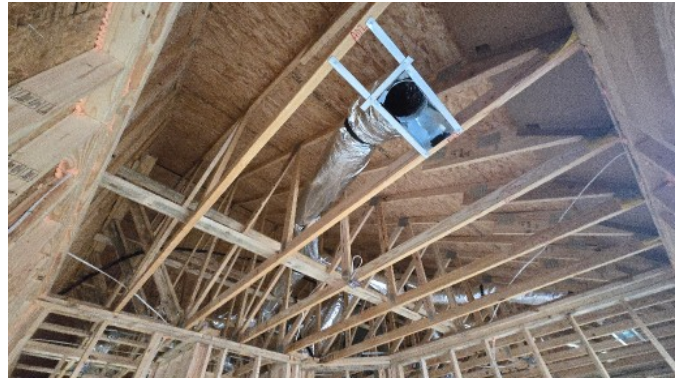
## 2.2) Attic Conditions

Roof Frame Type                      The roof framing is constructed with truss framing.

The visible and accessible portions of the attic appeared to be in serviceable condition at the time of the inspection.

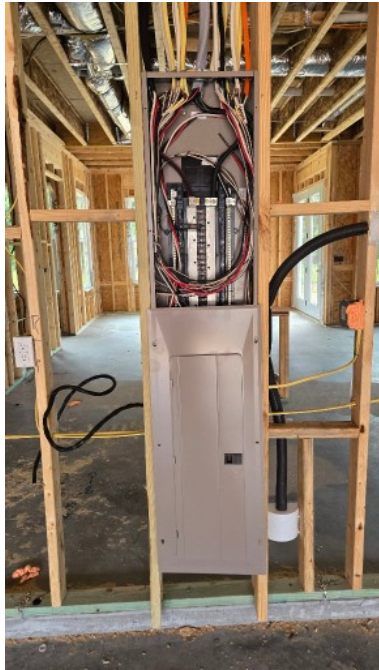
#### 3.1) Electrical Conditions

**Electrical Panel Location** The electrical panel is located in the garage.

The electrical panel was observed to be installed and in a generally serviceable condition during the pre-drywall inspection; however, no breakers had been provided at the time of inspection. The panel installation was incomplete. It is recommended that a qualified electrician install the required breakers and complete the panel setup in accordance with the National Electrical Code (NEC) before drywall installation proceeds.

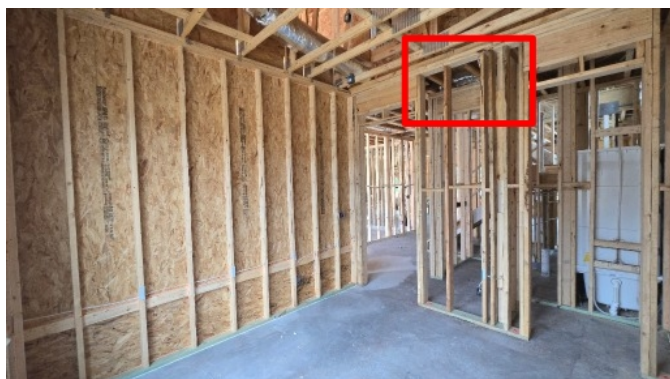
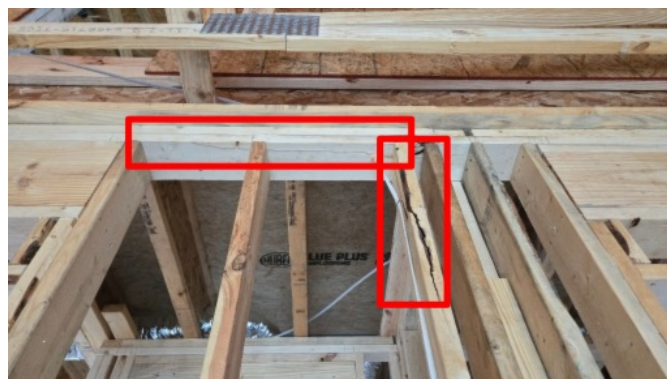
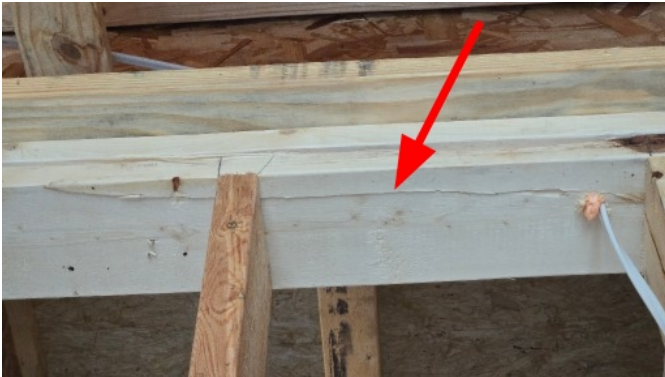
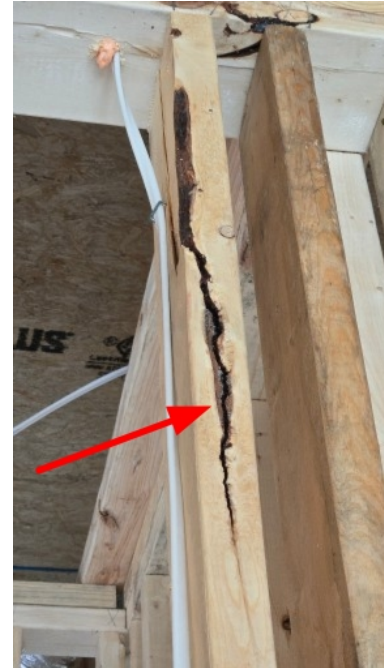
#### 5.1) Wall Conditions

A wall stud in the room to the right of the front door was observed with a significant longitudinal split/crack. The extent of the splitting exceeds what is typically considered minor seasoning checks and may affect the structural performance of the member. Recommend evaluation by the builder and replacement or reinforcement of the damaged framing member as deemed necessary prior to installation of drywall.

A wall stud in the room to the right of the front door was observed with a significant longitudinal split/crack. The extent of the splitting exceeds what is typically considered minor seasoning checks and may affect the structural performance of the member. Recommend evaluation by the builder and replacement or reinforcement of the damaged framing member as deemed necessary prior to installation of drywall.

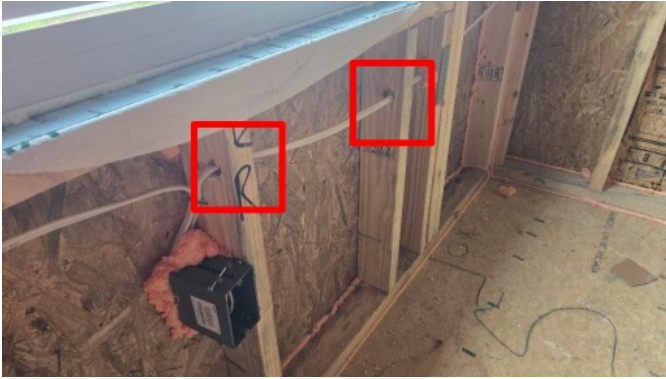
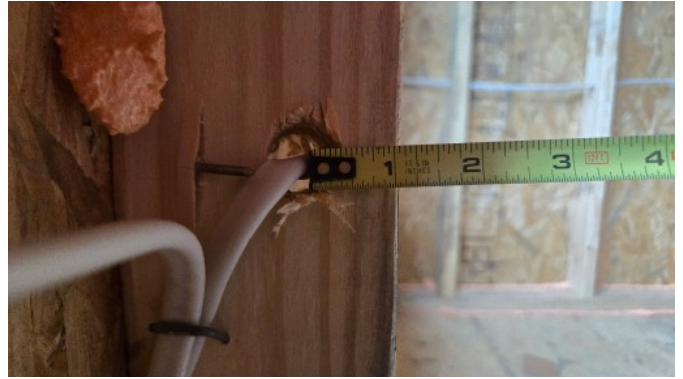
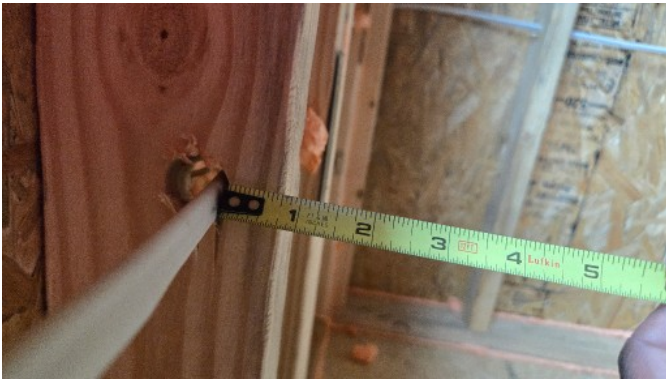
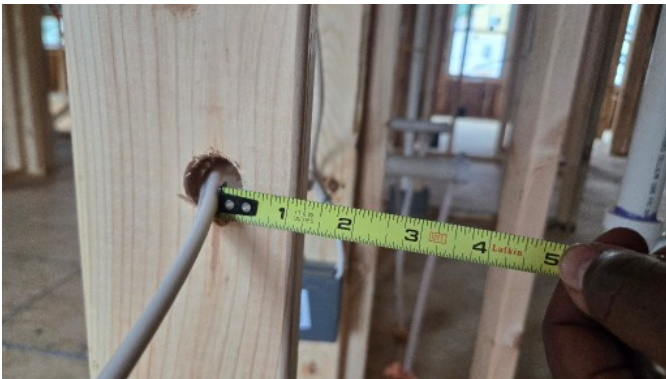
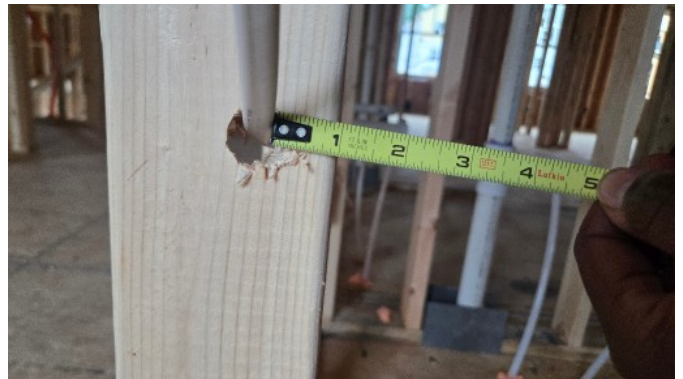
### 5.4) Electrical Conditions

Protective nail plates were missing at one or more locations where wiring and plumbing piping passed through framing members within the required clearance of the stud or framing surface. Without proper protection, these components may be susceptible to damage from drywall fasteners or future wall-mounted installations. Recommend installation of approved nail plates in accordance with current building standards prior to drywall installation.

Protective nail plates were missing at one or more locations where wiring and plumbing piping passed through framing members within the required clearance of the stud or framing surface. Without proper protection, these components may be susceptible to damage from drywall fasteners or future wall-mounted installations. Recommend installation of approved nail plates in accordance with current building standards prior to drywall installation.

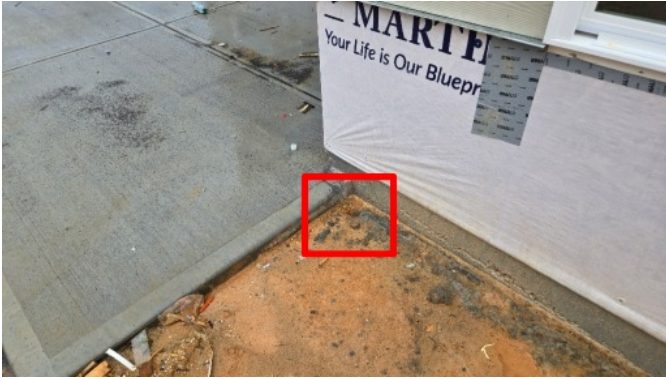
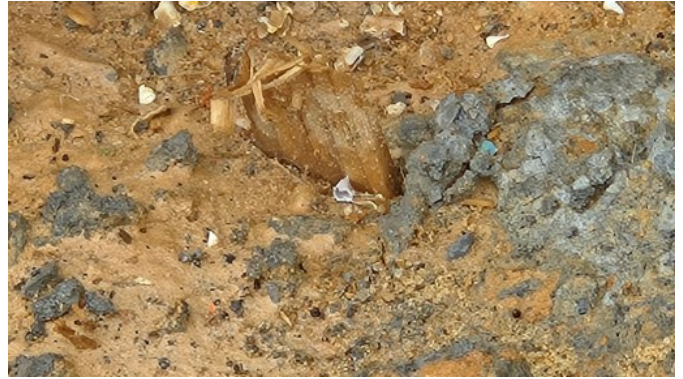
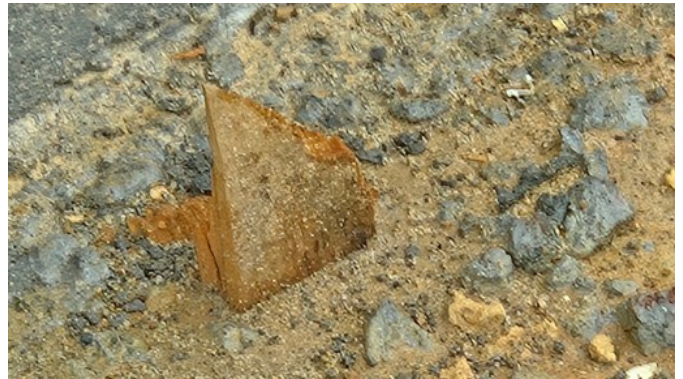
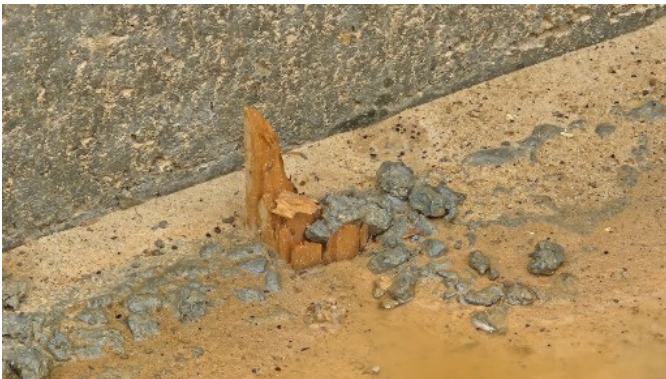
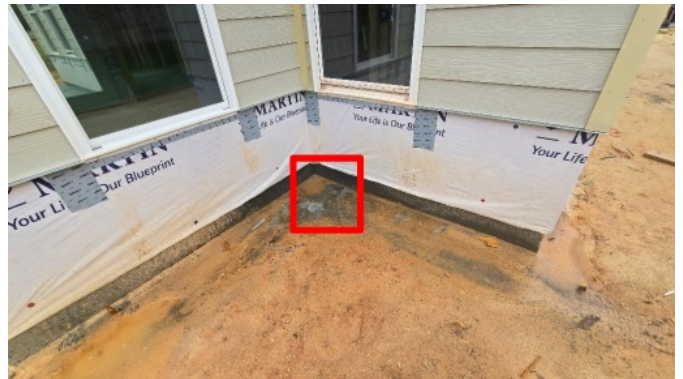
#### 6.1) Foundation Conditions

Scrap wood debris was observed in contact with the soil near the foundation in multiple areas. Wood left in contact with the ground can attract wood-destroying insects and contribute to moisture-related issues at the foundation. It is recommended that all scrap wood be removed from around the foundation to help prevent pest activity and maintain proper site cleanliness. Shrinkage cracks were observed in the concrete slab. Minor cracking is common as concrete cures and is often considered a normal characteristic of concrete construction. No significant displacement was observed at the time of the inspection. Recommend the builder evaluate the cracks and repair or seal them as necessary in accordance with the builder's warranty standards and industry-accepted construction practices. Honeycombing and voids were observed in the concrete foundation at the garage vehicle entrance opening. The affected area exhibited incomplete concrete consolidation and localized surface deterioration. Although the extent of any structural impact could not be determined during this inspection, defects in foundation concrete should be addressed prior to completion of construction. Recommend evaluation and repair by the builder in accordance with accepted construction practices.

Scrap wood debris was observed in contact with the soil near the foundation in multiple areas. Wood left in contact with the ground can attract wood-destroying insects and contribute to moisture-related issues at the foundation. It is recommended that all scrap wood be removed from around the foundation to help prevent pest activity and maintain proper site cleanliness. Shrinkage cracks were observed in the concrete slab. Minor cracking is common as concrete cures and is often considered a normal characteristic of concrete construction. No significant displacement was observed at the time of the inspection. Recommend the builder evaluate the cracks and repair or seal them as necessary in accordance with the builder's warranty standards and industry-accepted construction practices. Honeycombing and voids were observed in the concrete foundation at the garage vehicle entrance opening. The affected area exhibited incomplete concrete consolidation and localized surface deterioration. Although the extent of any structural impact could not be determined during this inspection, defects in foundation concrete should be addressed prior to completion of construction. Recommend evaluation and repair by the builder in accordance with accepted construction practices.
