# Inspection Report

## Friendly Home Inspections

Sample Report

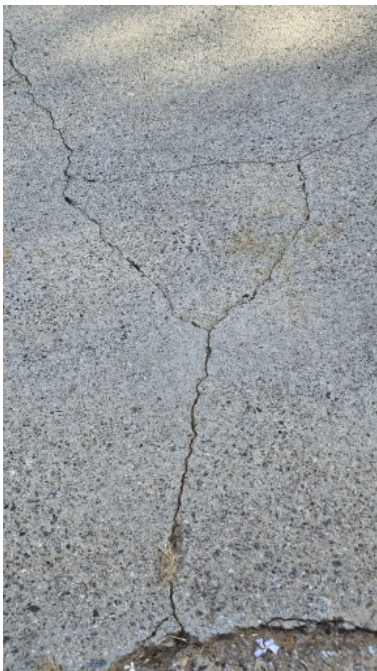
The driveway exhibited multiple cracks. Recommend sealing and monitoring the cracks to help prevent further deterioration and reduce moisture intrusion.

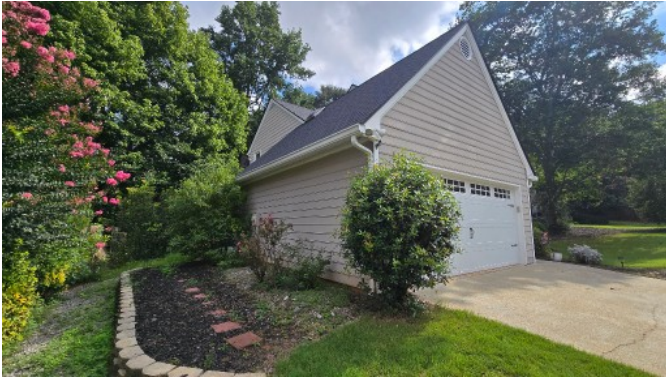
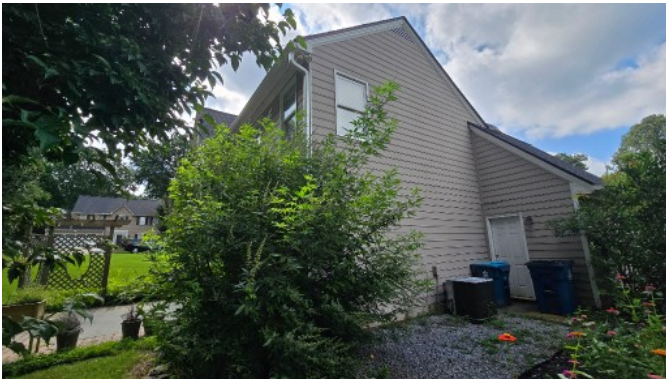
### 2.3) Exterior Wall Conditions

Cracked and deteriorated siding, damaged sealant, and open gaps were observed at multiple exterior wall locations. Vegetation was also in contact with the siding. Recommend repairing and sealing the affected areas and trimming vegetation to help prevent moisture intrusion and further deterioration.

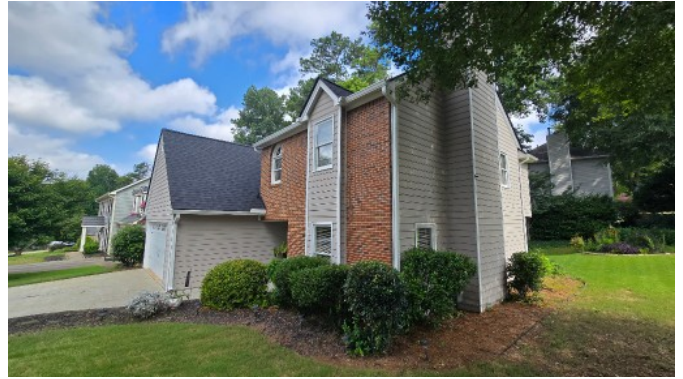
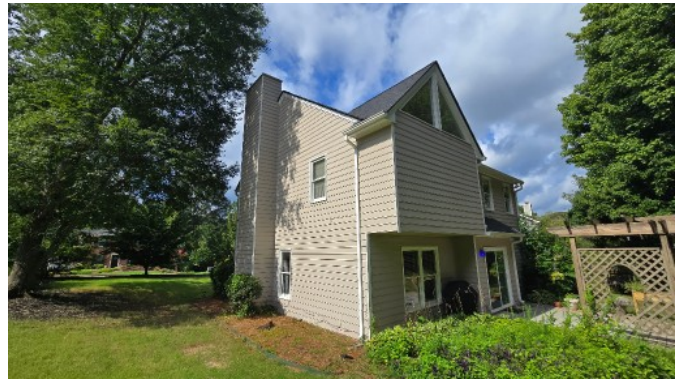
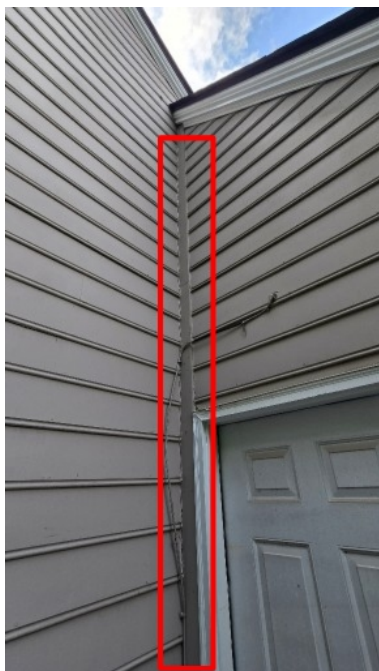
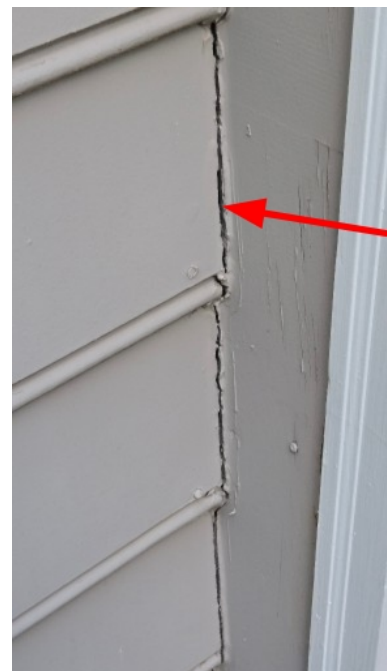
Cracked and deteriorated siding, damaged sealant, and open gaps were observed at multiple exterior wall locations. Vegetation was also in contact with the siding. Recommend repairing and sealing the affected areas and trimming vegetation to help prevent moisture intrusion and further deterioration.

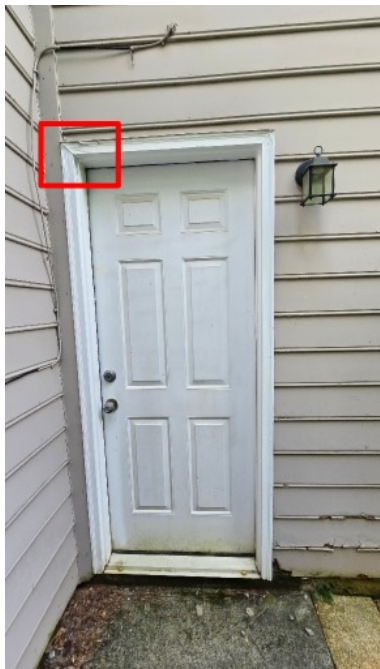
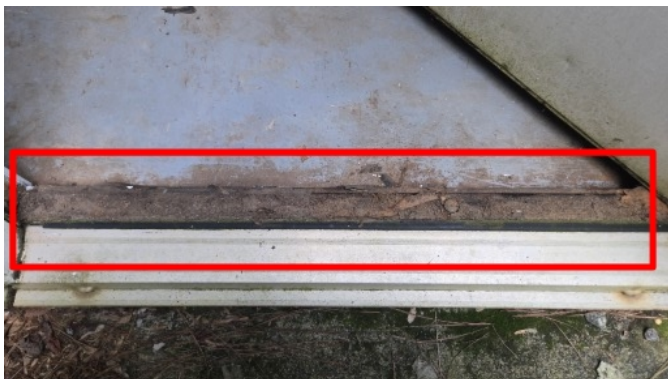
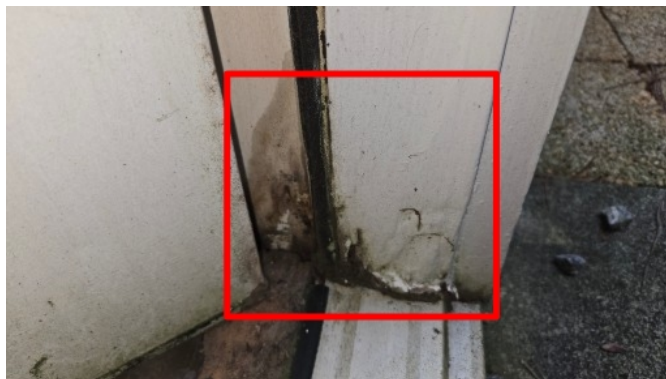
The exterior door trim and threshold exhibited wood rot and deterioration. Recommend repairing the damaged components. The garage exterior door was equipped with a double-keyed deadbolt, which may present a life-safety concern by delaying emergency egress if a key is not readily available. The front entry door also stuck at the door frame, making it difficult to operate. Recommend replacing the double-keyed deadbolt with a single-cylinder deadbolt (where appropriate) and adjusting the door to ensure proper operation.

The exterior door trim and threshold exhibited wood rot and deterioration. Recommend repairing the damaged components. The garage exterior door was equipped with a double-keyed deadbolt, which may present a life-safety concern by delaying emergency egress if a key is not readily available. The front entry door also stuck at the door frame, making it difficult to operate. Recommend replacing the double-keyed deadbolt with a single-cylinder deadbolt (where appropriate) and adjusting the door to ensure proper operation.

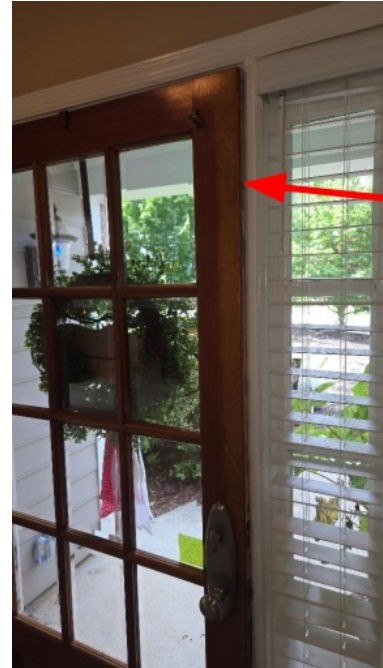
Door sticks to the frame

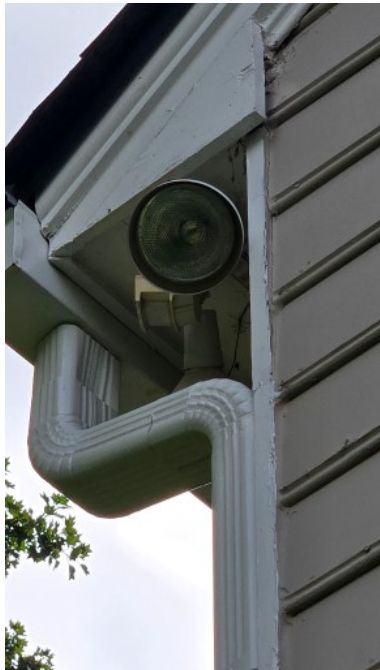
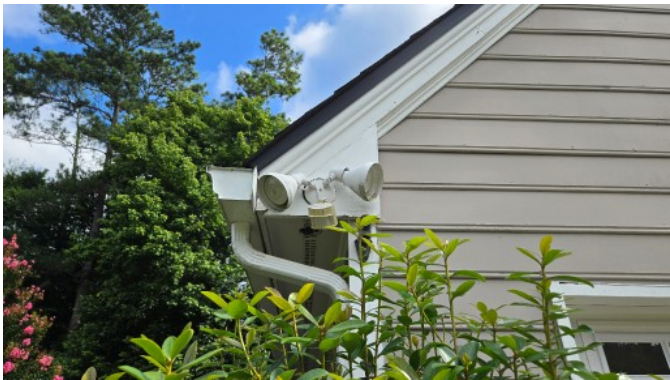
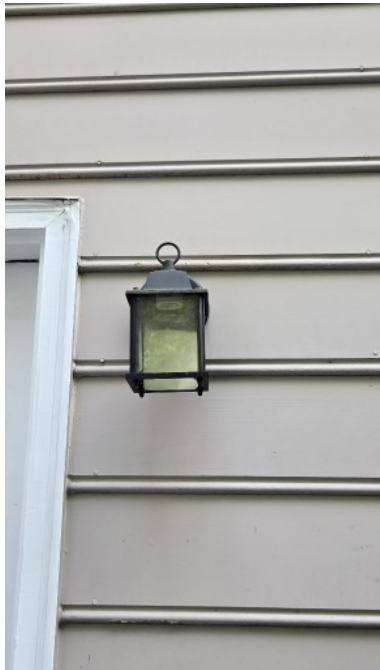
### 2.7) Lighting Conditions

Lights were inoperative on the front and back left corners of the home. Dismantling and testing of all light fixtures is not performed as part of this inspection. Recommend all lights be operable prior to close. A light bulb was missing at the exterior garage door, therefore the fixture and switch could not be tested.

Missing light bulb

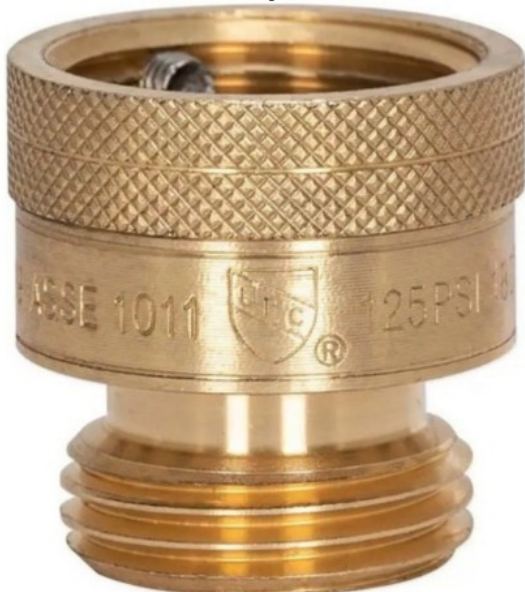
### Back-flow preventer

Back-flow preventers were not installed on the faucets. A back-flow preventer is a crucial device designed to prevent contaminated water from flowing back into the home's potable water supply, ensuring the safety and integrity of the water system. This device is important for outdoor hose bibs, irrigation systems, and any cross-connections where there is a risk of back-siphonage or back-pressure. The hose faucets were operational at the time of the inspection. These should be drained prior to freezing temperatures.

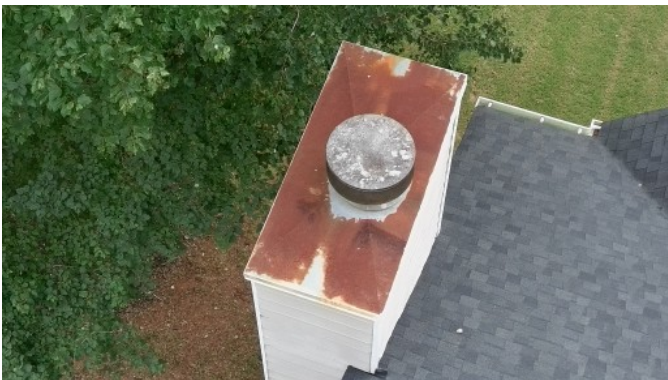
The metal chimney cap and crown are heavily rusted, which could lead to water intrusion and accelerated corrosion of the metal components. The liners for furnace or fireplaces were not inspected by our company. I recommend a qualified chimney sweep inspect for safety.

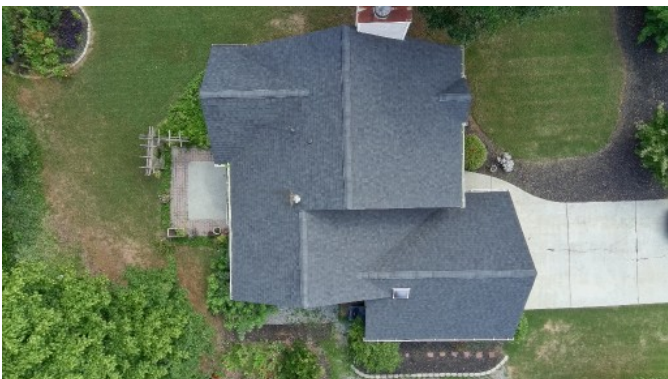
The roof was not mounted due to height. The roof was inspected by viewing with high power binoculars and drone.

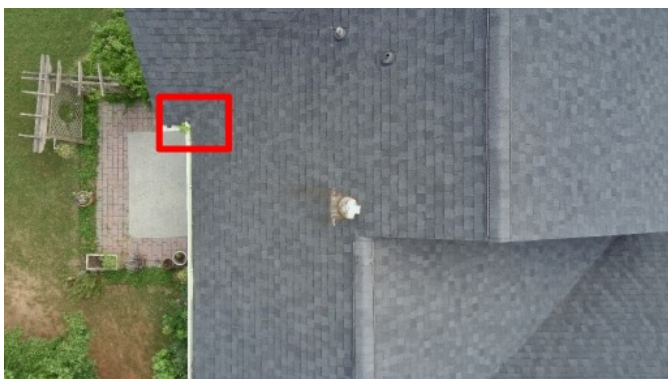
Vegetation was observed growing in the gutter on the back of the home. Recommend cleaning the gutters to promote proper drainage and help prevent moisture-related damage.

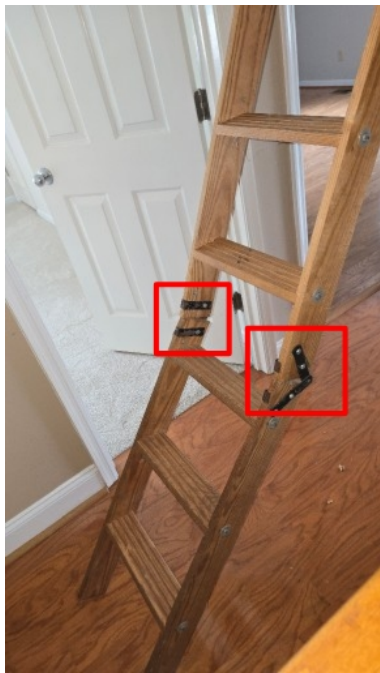
Attic Access

The attic pull-down ladder hinges were loose. Recommend repair to ensure the ladder is properly secured and safe to operate.

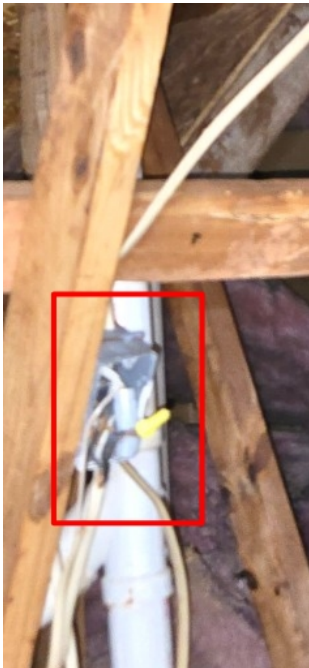
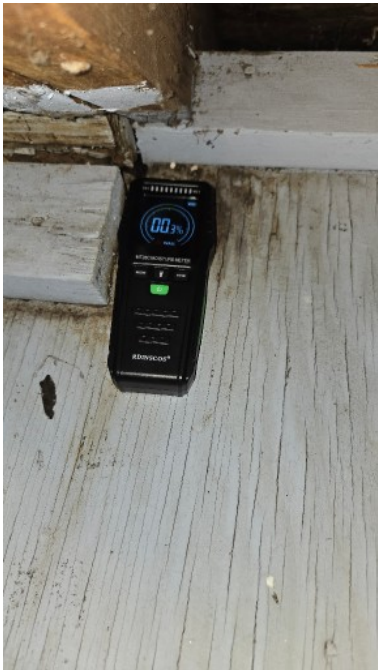
A light switch box cover was missing near the attic entrance at the time of the inspection. Recommend installation of covers for increased safety. Water staining was observed on the attic framing/sheathing; however, no elevated moisture was detected at the time of the inspection. Recommend monitoring the area and repairing any active leaks if they develop.

No moisture detected

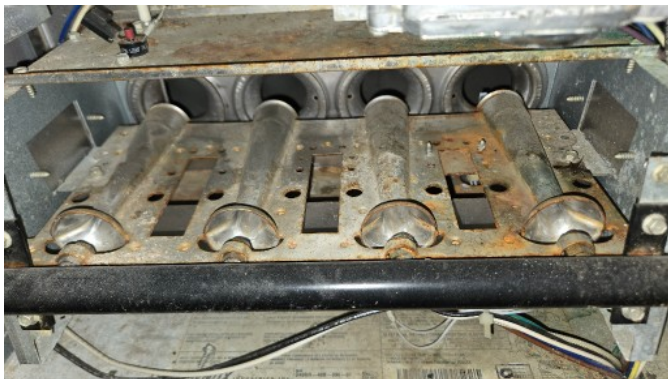
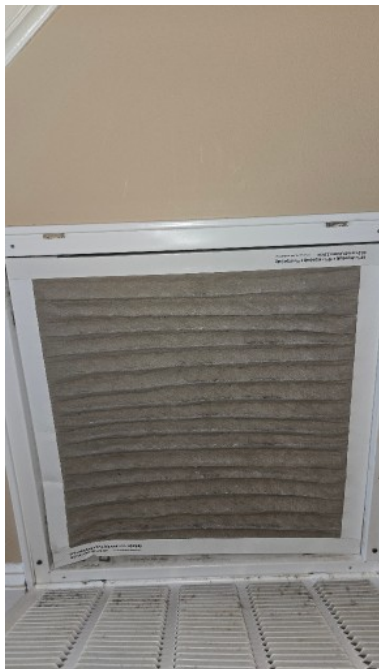
The heating unit had excessive rust and / or flakes in the burner chamber. Due to conditions observed, recommend complete system evaluation, cleaning and servicing of heating system by a licensed / qualified heating contractor prior to close. The air filters were dirty. Suggest replacing as soon as possible. To increase the efficiency of your heating system, we recommend changing your systems filter regularly ( every 2-3 months ). The furnace was manufactured in 2004 and is beyond its typical service life. Due to its age, budget for replacement and have the system serviced annually by a qualified HVAC contractor. The outside air temperature was above 65

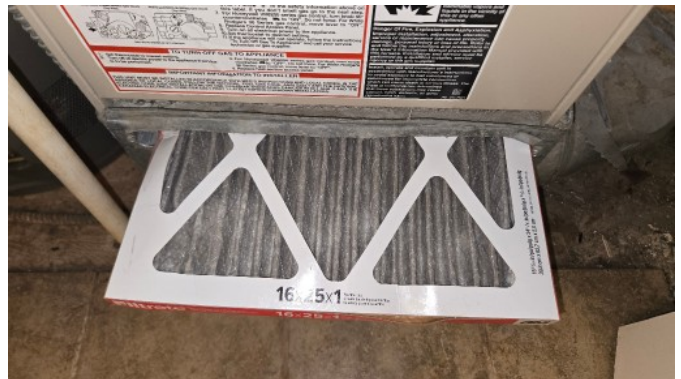
4.1) Unit Conditions

degrees at the time of the inspection. Operating the system at this temperature could have an inaccurate reading from the system, therefore the inspector was unable to operate and test the system at the time of inspection. We advise client to consult with their attorney for information on this typical warm weather real estate transaction scenario. Since the weather is beyond our control, we will return to inspect for a nominal return trip fee of \$125.00 if desired. Should re-inspection be scheduled with our office, please allow 72 hour notice (dependent on weather and ambient temperatures).

The heating unit had excessive rust and / or flakes in the burner chamber. Due to conditions observed, recommend complete system evaluation, cleaning and servicing of heating system by a licensed / qualified heating contractor prior to close. The air filters were dirty. Suggest replacing as soon as possible. To increase the efficiency of your heating system, we recommend changing your systems filter regularly ( every 2-3 months ). The furnace was manufactured in 2004 and is beyond its typical service life. Due to its age, budget for replacement and have the system serviced annually by a qualified HVAC contractor. The outside air temperature was above 65 degrees at the time of the inspection. Operating the system at this temperature could have an inaccurate reading from the system, therefore the inspector was unable to operate and test the system at the time of inspection. We advise client to consult with their attorney for information on this typical warm weather real estate transaction scenario. Since the weather is beyond our control, we will return to inspect for a nominal return trip fee of \$125.00 if desired. Should re-inspection be scheduled with our office, please allow 72 hour notice (dependent on weather and ambient temperatures).

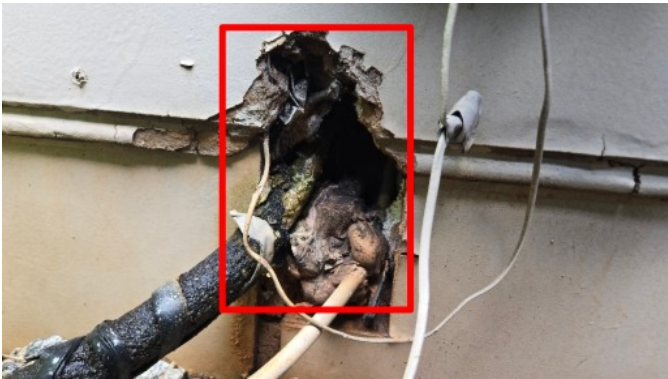
Recommend sealing where A/C lines penetrate the exterior wall. The outdoor air conditioning unit was manufactured in 2011 and is approaching the end of its typical service life. Although it may have been operational at the time of the inspection, its age increases the likelihood of future repairs or replacement. Budget for replacement and have the system serviced annually by a qualified HVAC contractor.

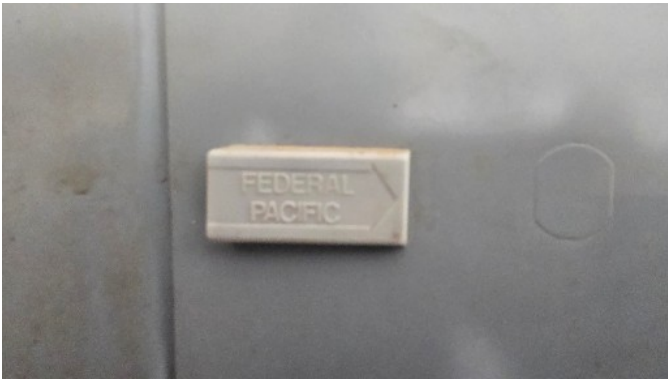
An abandoned conductor was observed inside the electrical panel with its end wrapped in electrical tape. Recommend evaluation and proper termination or removal by a qualified electrician. The electrical panel directory contained minimal circuit labeling. Recommend properly identifying all circuits to improve safety and ease future servicing. The panel manufacturer is Federal Pacific. The company is no longer in business. Thousands of these panels were installed from about the 60's to the early 80's. In some cases, problems have been associated with breakers not tripping when needed. Client is advised to consult a licensed electrician for further information.

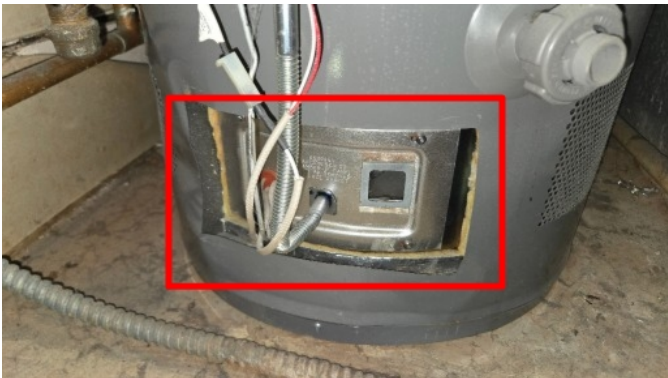
The burner cover door was not present. Recommend replacement of burner cover door. The water heater's manufacturer label was missing, preventing verification of the unit's identification and specifications.

Missing cover

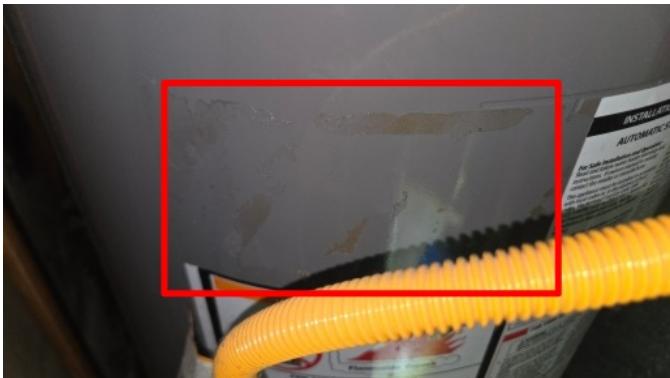
Missing label

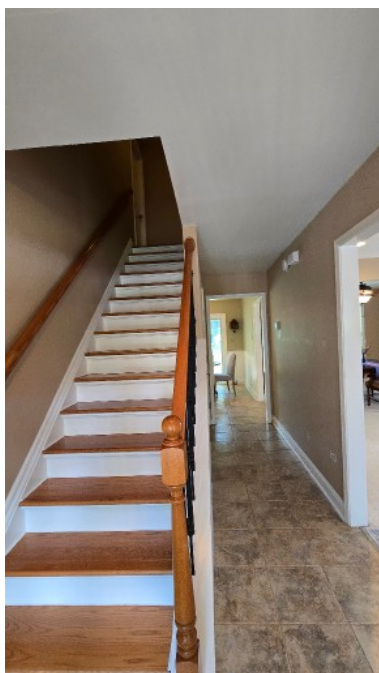
7.1) Wall Conditions

A vertical crack was observed in the living room wall. Recommend monitoring for movement and repairing as needed if the crack widens or continues to develop. Furnishings, pictures, wall coverings, and personal item storage prevented a full visual inspection of all areas. Conditions can change between the time of inspection and closing. Client is advised to perform a careful check of all areas during final walk through. Client is advised to note any staining or conditions that may not have been visible during the time of inspection. Such conditions should be brought to your Realtor (if applicable) or Attorney's attention prior to closing of this property.

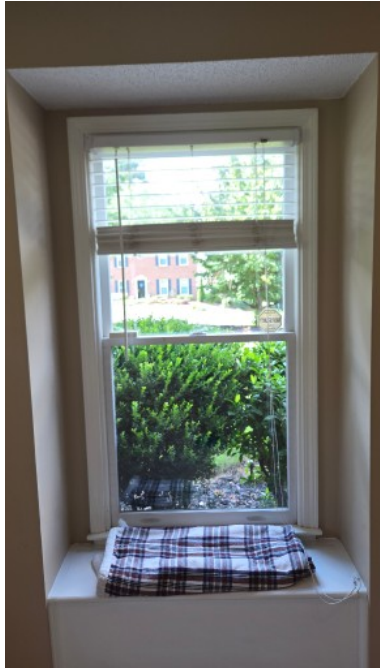
There were two living room windows painted shut and could not be opened without excessive force. This could be a safety concern. The back master bedroom and side guest bedroom window locks were unable to latch due to the windows being painted shut and difficult to operate. Recommend repairs be made to allow windows to operate freely.

Did not open

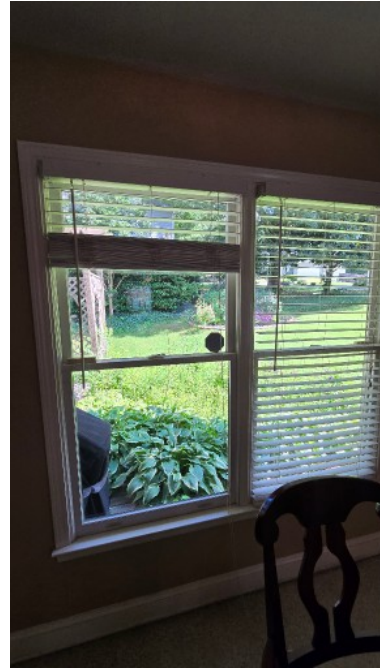
Did not open

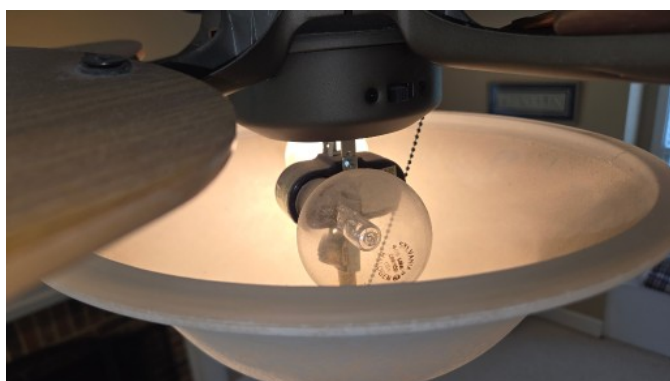
### 7.8) Lighting Conditions

A light was inoperative on the living room ceiling fan. Dismantling and testing of all light fixtures is not performed as part of this inspection. Recommend all lights be operable prior to close.

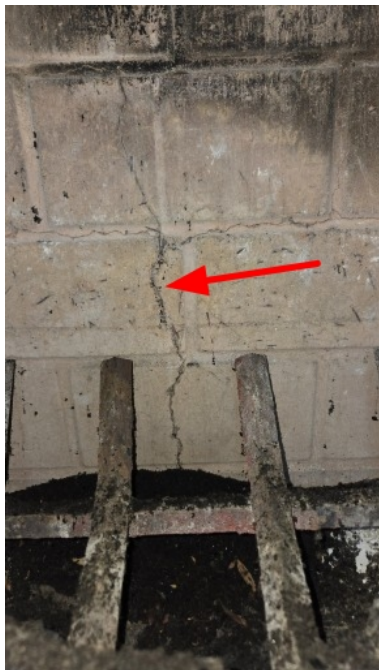
At the fireplace, cracked or loose firebricks were observed. Recommend repair as needed by a qualified fireplace contractor. Recommend chimney flue cleaning by a chimney sweep specialist. Creosote can accumulate and become a fire hazard if the fireplace and flue are not cleaned regularly.

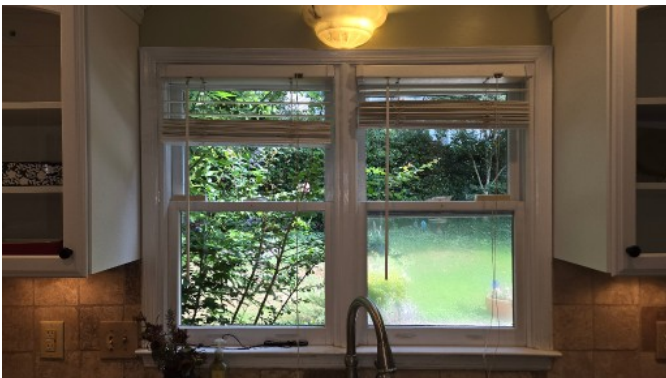
The windows were painted shut and could not be opened without excessive force. This could be a safety concern. Recommend repairs be made to allow windows to operate freely.

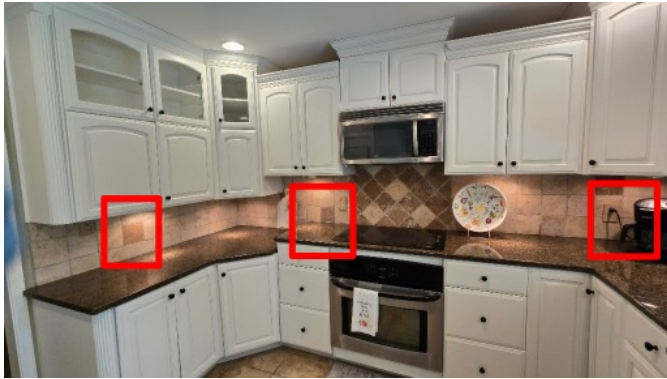
No ground fault circuit interrupter (GFCI) protection of electrical receptacles was provided on 3 counter outlets. Although GFCI protection may not have been required when this home was built, modern electrical safety standards require GFCI protection of receptacles at certain locations in the home. You should consult with a qualified electrical contractor to discuss options and costs for installation of GFCI protection.

No GFCI at outlets

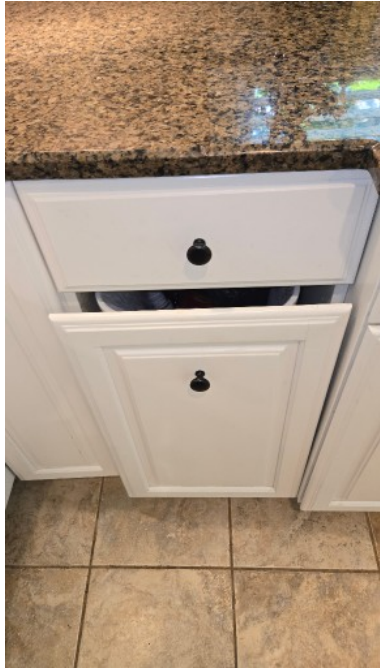
The trash can cabinet door did not close properly. Recommend adjustment or repair for proper operation.

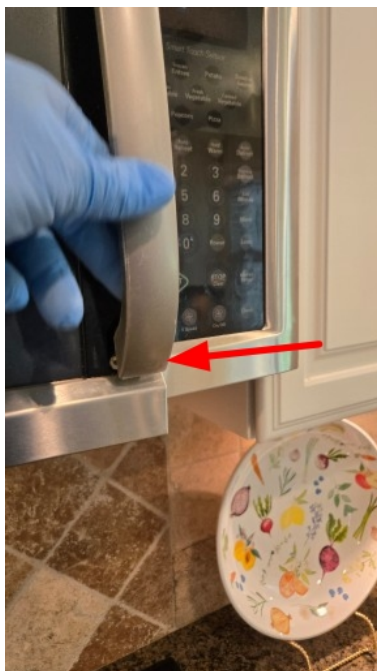
The microwave door handle was loose. Recommend repair or replacement to ensure proper operation. While the ducted-type exhaust fan was functional, no exhaust duct to the exterior was installed. The inspector recommends that an exhaust duct be installed to exhaust moisture and odor created during cooking to the home exterior. The hood light was in operational condition at the time of the inspection.

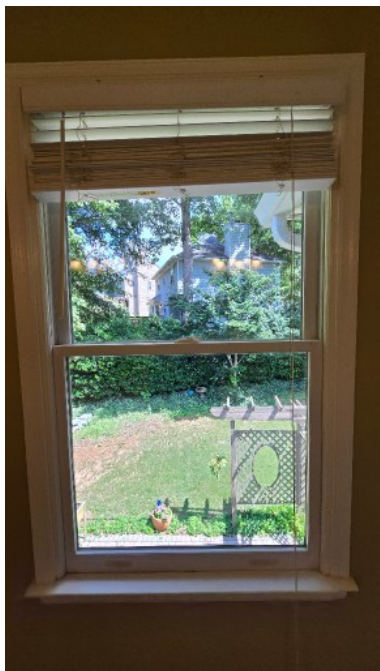
The master bathroom window was painted shut or could not be opened without excessive force. This could be a safety concern. Recommend repairs be made to allow windows to operate freely.

Did not open

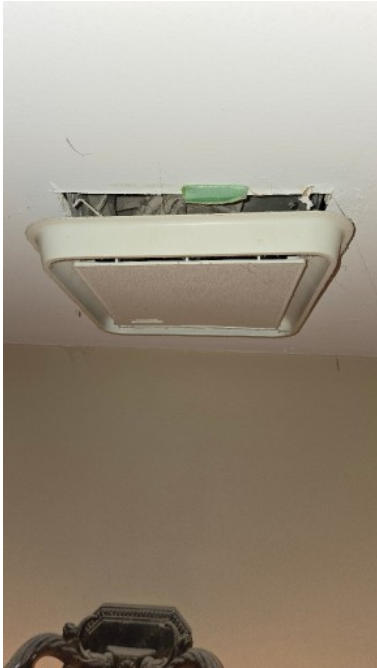
#### 9.8) Vent Fan Conditions

The first-floor bathroom exhaust fan cover was loose and not properly secured. Recommend repair or replacement to ensure proper operation and prevent further damage. Window ventilation only was observed in the 2nd floor guest bathroom. While this is considered adequate by today's standards, we strongly advise the installation of a powered ventilation system. Failure to remove excess moisture from bathrooms can cause mold and moisture conditions.

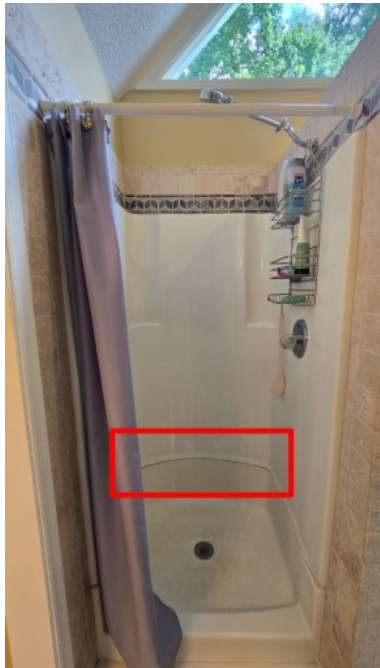
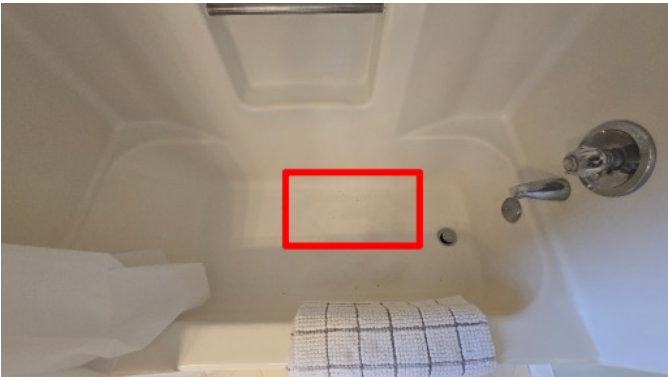
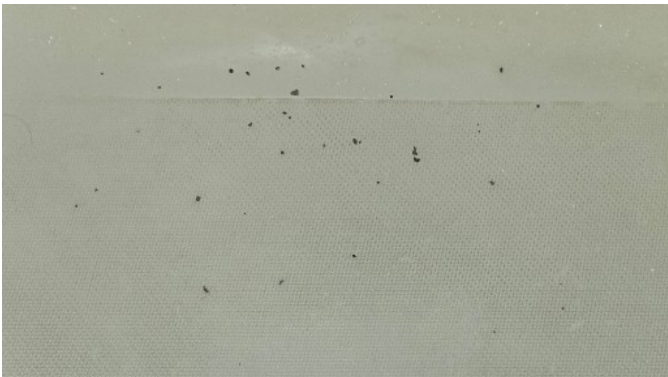
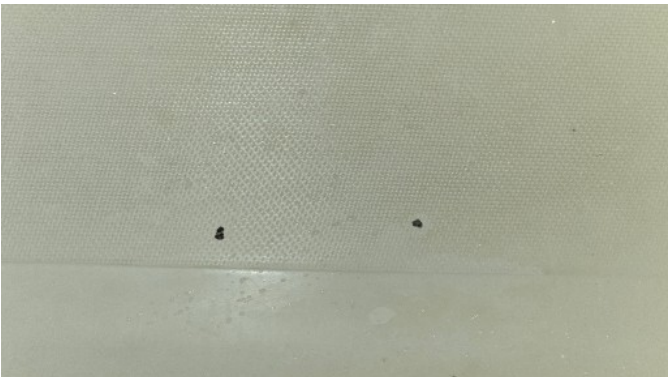
### 9.11) Shower - Tub Conditions

Chips were observed in the guest bathtub finish. These should be repaired to prevent rust and/or corrosion. Dark staining was observed on the master shower walls. Recommend cleaning/further evaluation of the staining as needed.

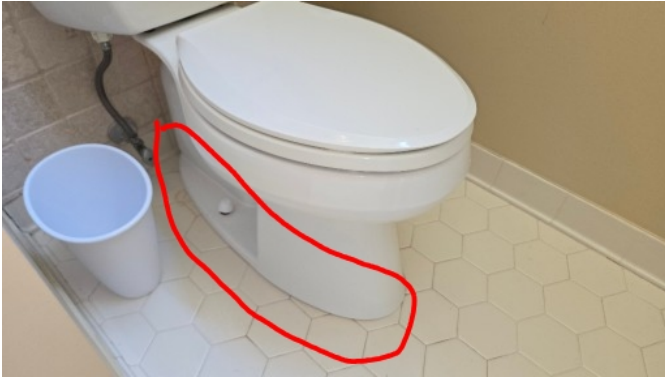
9.12) Toilet Conditions

The toilet was loose at the floor in the master bathroom. Recommend securing / repair as needed. While this condition is somewhat common, it can increase the likelihood that some water penetration may have occurred at the base / wax seal area of the floor.

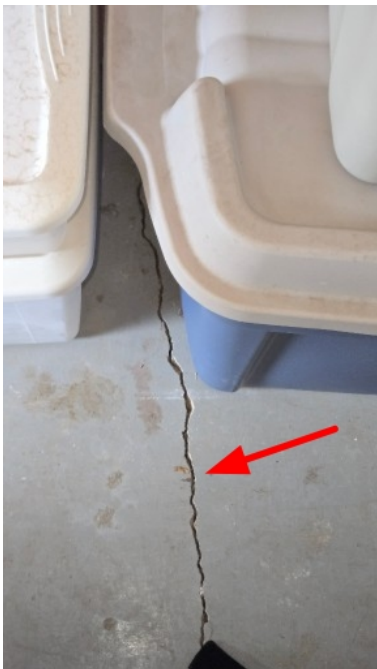
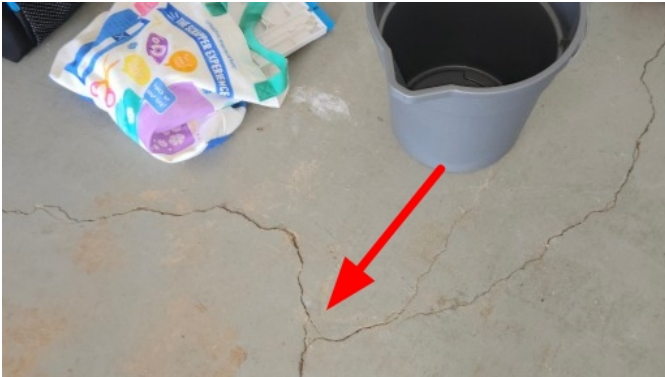
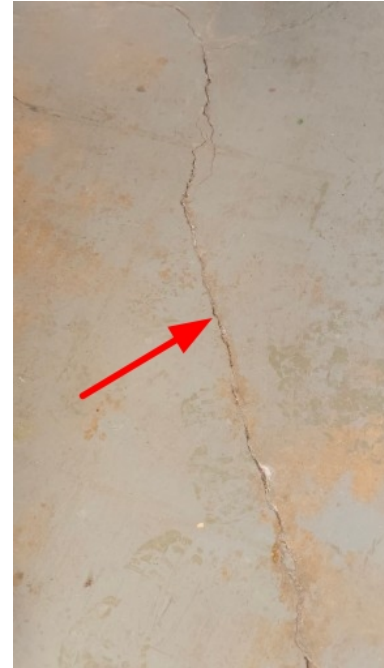
### 10.3) Floor Conditions

Cracks were observed in the garage concrete floor. These appear consistent with typical concrete shrinkage; Recommend sealing, monitor for movement or widening and repair as needed to prevent further deterioration.

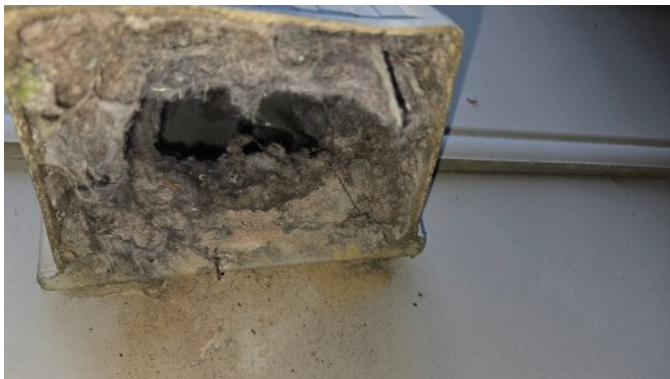
10.8) Laundry Room Conditions

For increased fire safety, recommend cleaning of lint from extended exhaust duct on a regular basis. The visible and accessible portions of the laundry plumbing components appeared to be in serviceable condition at the time of inspection.
