# Inspection Report

## Friendly Home Inspections

Sample Report

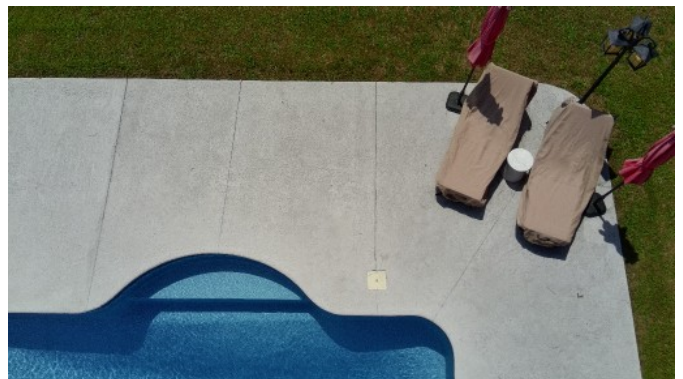
### 1.3) Pool Decking Conditions

Cracking and separation were present in portions of the pool decking. These conditions may worsen from moisture intrusion and continued movement and could eventually create a trip hazard. Recommend sealing the cracks and separated joints with an appropriate flexible material and repairing displaced areas as needed.

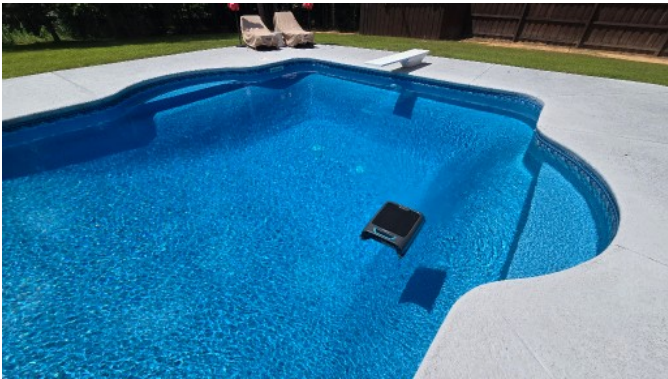
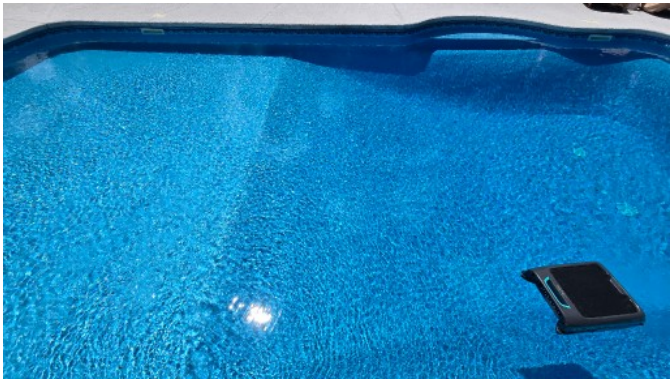
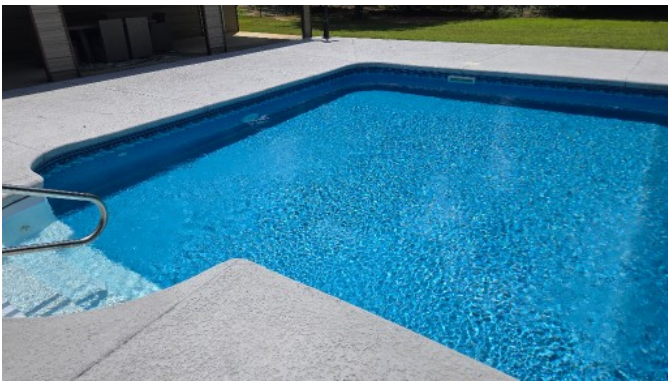
1.4) Pool Interior Finish Conditions AS

The interior finish was in serviceable condition at the time of the inspection.

The skimmer boxes and their covers were in serviceable condition at the time of the inspection.

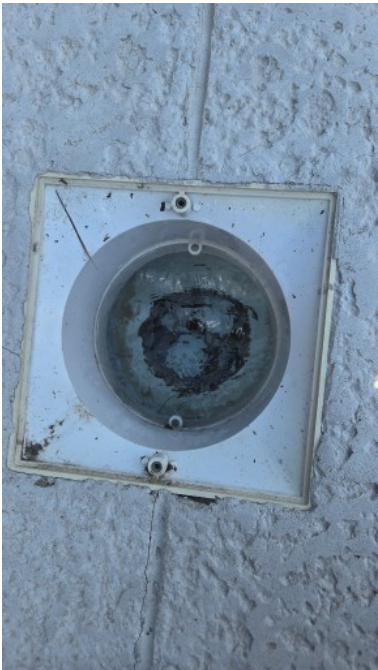
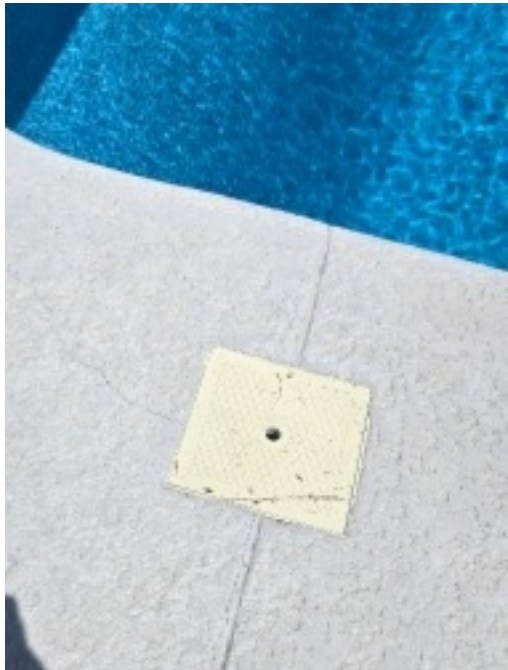
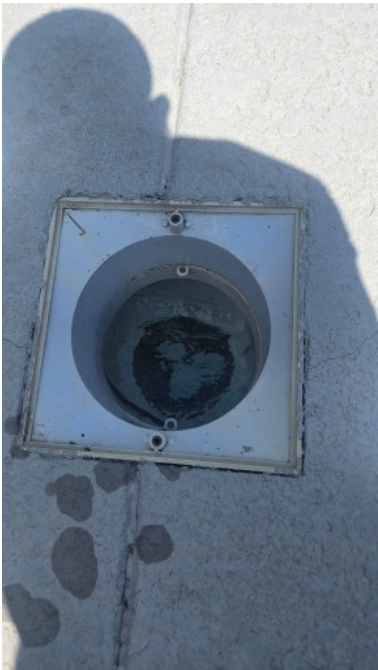
1.6) Weir Gate Conditions

The weir gates were functional at the time of the inspection.

The drain covers appeared to be functional at the time of the inspection. Debris was observed collecting around the drain. Recommend drains be cleaned to provide proper water circulation.

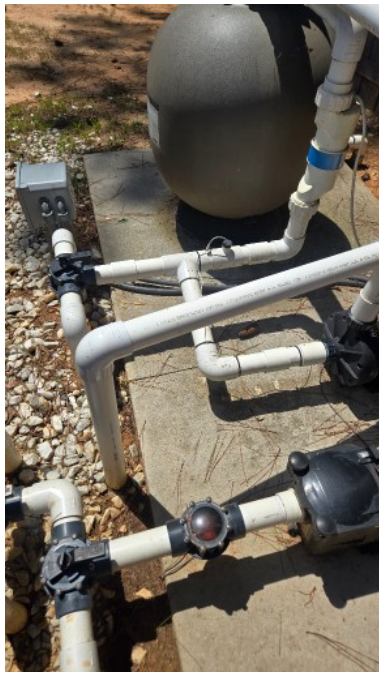
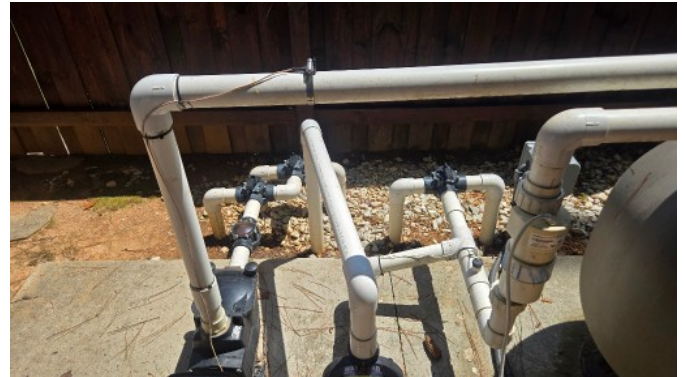
### 1.10) Piping Conditions

The supply lines and return lines are in acceptable condition, no leaking noted.

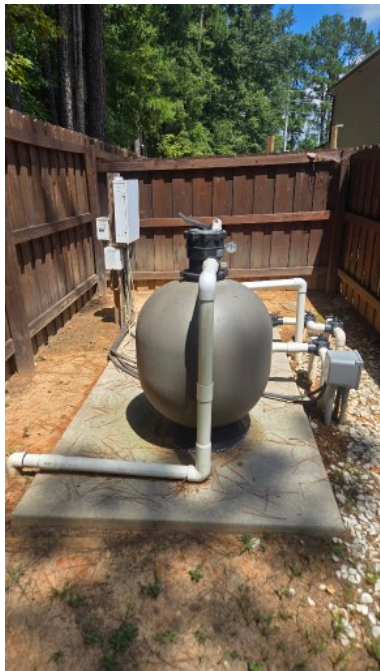
1.13) Electrical Panel Conditions

The electrical panel appeared to be in serviceable condition at the time of the inspection.

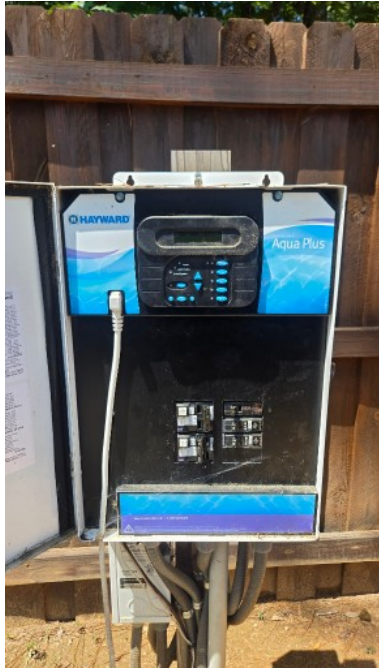
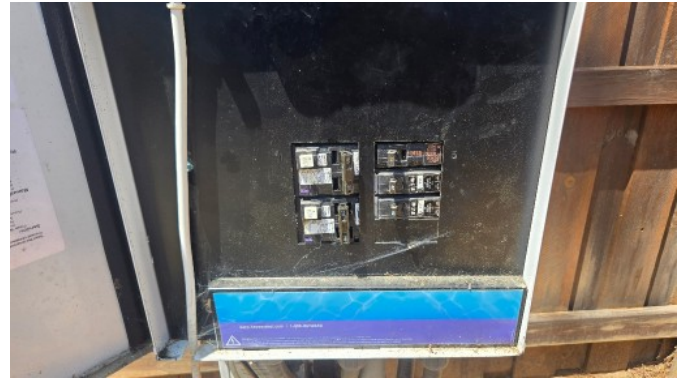
### 1.14) Timer Box Conditions

The timer was in operational condition at the time of the inspection.

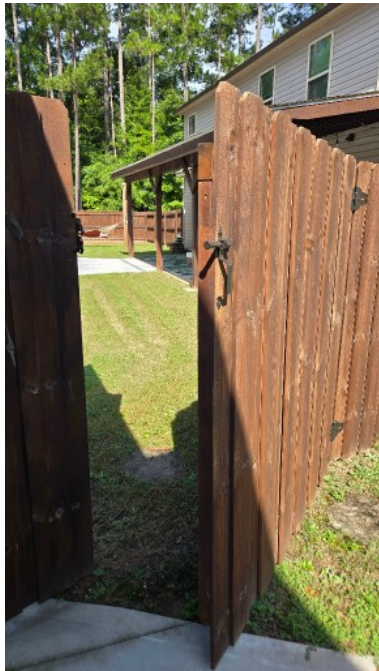
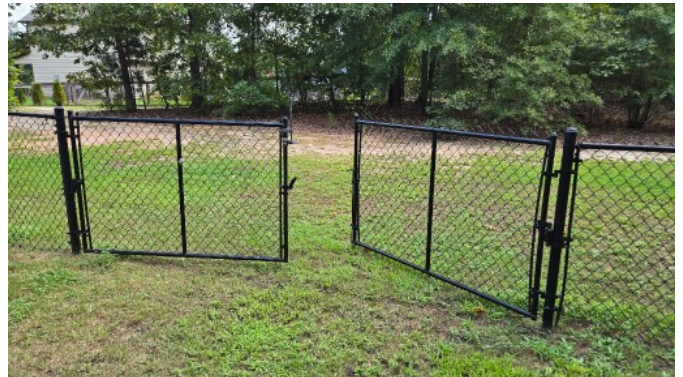
## 1.16) Gate Conditions

The pool gates did not close automatically. The gate door that leads into the rear yard where there is a pool, pond (greater than 18 inches deep) or spa, (including spas with locking covers) should be equipped with a self closing device that completely latches the gate when shut as per local building standards (we test at 12" away). Gates should close completely and latch and open outward away from the rear yard. Recommend repair.
