Inspection Report

Friendly Home Inspections

> Property Address 2510 Zane Dr SW Atlanta, GA 30331

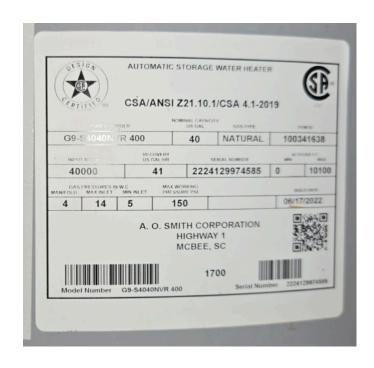
The water heater is located in the basement.
