Inspection Report

Friendly Home Inspections

Property Address 7376 Bluestone Dr Riverdale, GA 30296

Inspection Date March 4, 2022

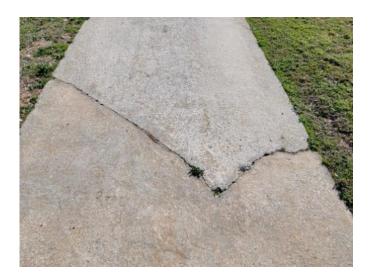
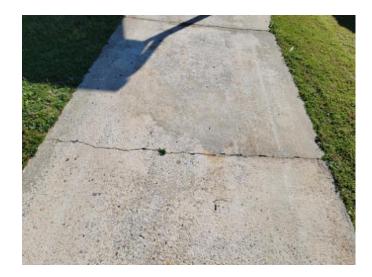
Common cracks were observed in the driveway. The driveway appeared to be in serviceable condition at the time of the inspection.

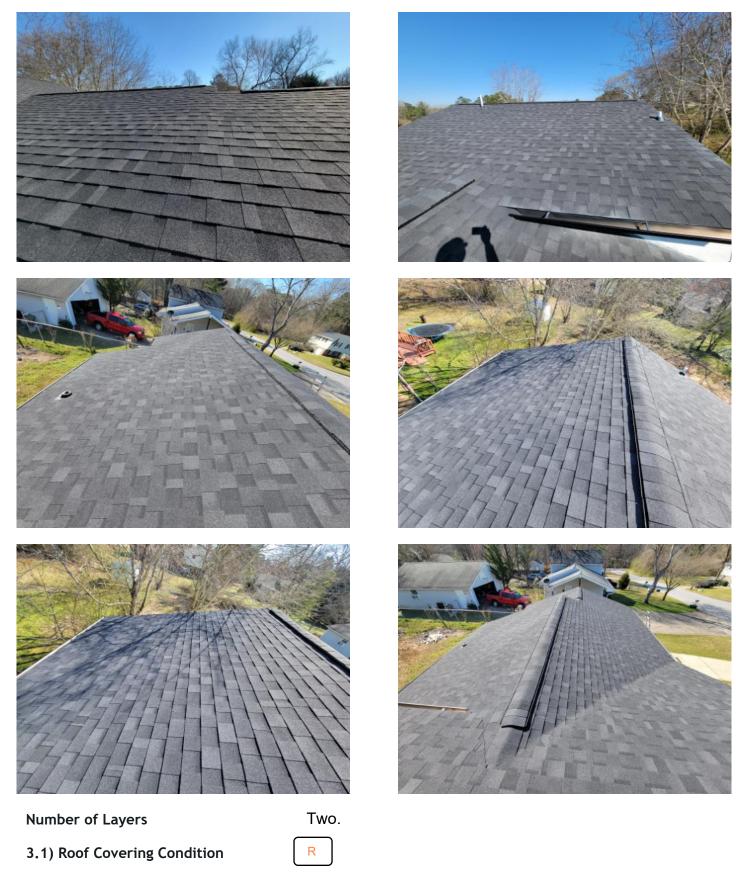
Minor sagging or depressions were observed to the roof sheathing and / or framing support. There looked to be an abandoned vent pipe hole over the kitchen area. This hole should be capped to

avoid water damage to the roof sheathing. Two layers of roof shingles appear to be present. Today's standards allow a maximum of two layers of shingles. It is suggested that a "Licensed Roofing Contractor" be contacted for further evaluation and repair.

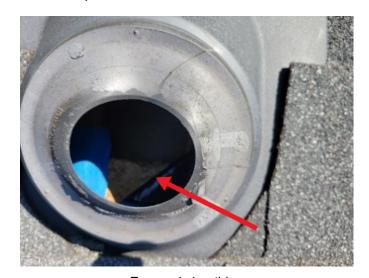
Exposed sheathing

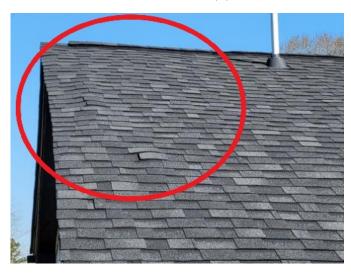
Curling shingles

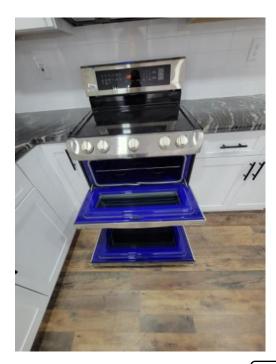
The stove and oven were not operational at the time of the inspection. Recommend repair and / or replacement.

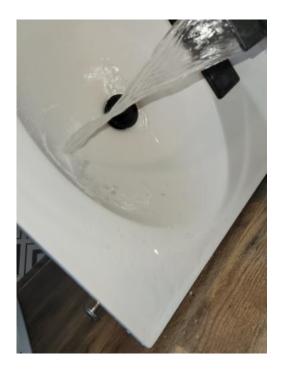
The basement sink faucet water splashes on the wall when the faucet is on. Repair may be warranted.

Water splashes on the wall

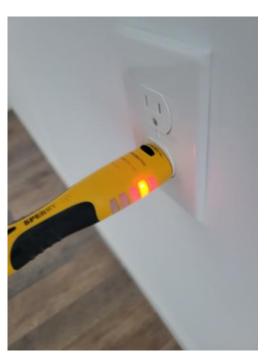
Three pronged outlets did not test for proper ground in the front bedroom. A missing outlet cover was observed in the utility closet. A junction box cover was missing in the laundry room. Recommend installation of covers for increased safety. Recommend further evaluation and repairs by a licensed electrician prior to close.

Open ground

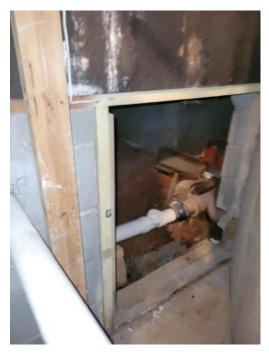
Crawlspace entrance in the utility closet

The base of the crawl space was soil. Client should consider installation of a plastic sheet vapor barrier over the soil to reduce moisture in the crawl space. Typical of this style home, the inspector was unable to fully inspect the foundation walls and floors due to the finished interior components. Also typical of this style home, the inspector was unable to fully inspect the main beam, floor joists and floorboards due to the finished ceiling and / or wall components. Areas behind the finished walls and ceilings were concealed and were not visible or accessible for inspection.
